FORMER L.W. WELLER BUILDING (1904)
(currently Chaska Family Chiropractic);
103 West Second Street

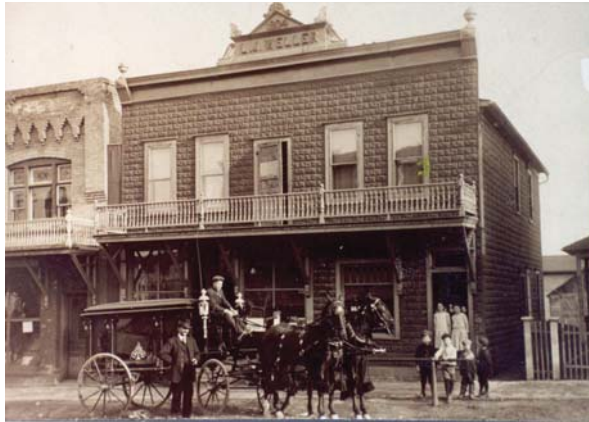
- Original pressed metal cladding material (which appears in historic photos) has been replaced with stucco, and the original projecting balcony has been replaced with canvas awnings. This results in a clean and neat front façade that is not historic, but is somewhat sympathetic to the historic context in scale, texture, and proportions.

- Cornice has been painted a contrasting dark color. Paint the inside of one projecting vent so it is less visible.
- Signage is subtle and not too unsympathetic to an historic context, although it might be better coordinated with the overall storefront concept.

- Consider reinstalling the historic building name block “cresting piece” above the cornice line, which could be re-fabricated from galvanized sheet metal.

- In the long-range, consider reinstalling the projecting, bracketed balcony that clearly shows on historic photos of the building.

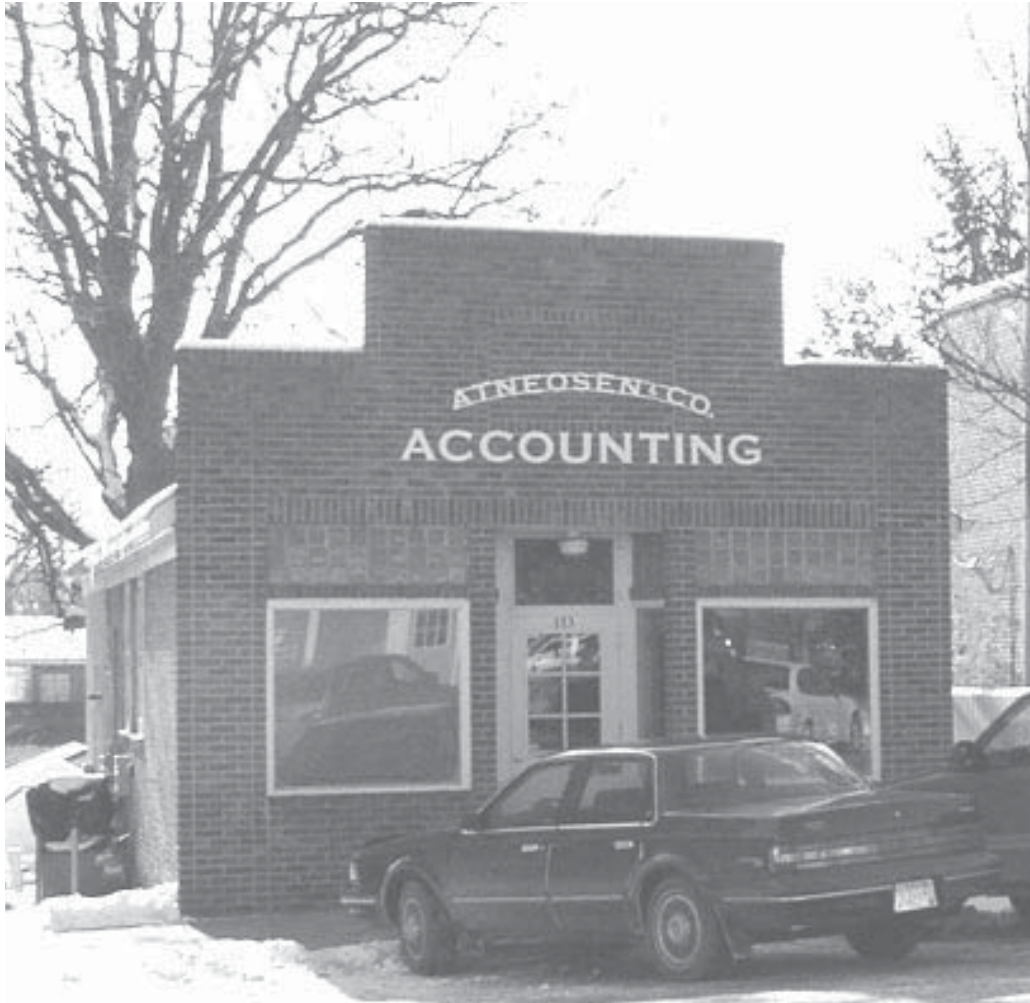
Existing Condition

- Repair of eave trim boards was in progress at the time this building was surveyed. Chaska brick on the east side wall appears to have been recently stripped.
- Condition of all exterior materials is sound and well-maintained.
- Existing signage, applied flat to the upper façade, is appropriate, though not historic.

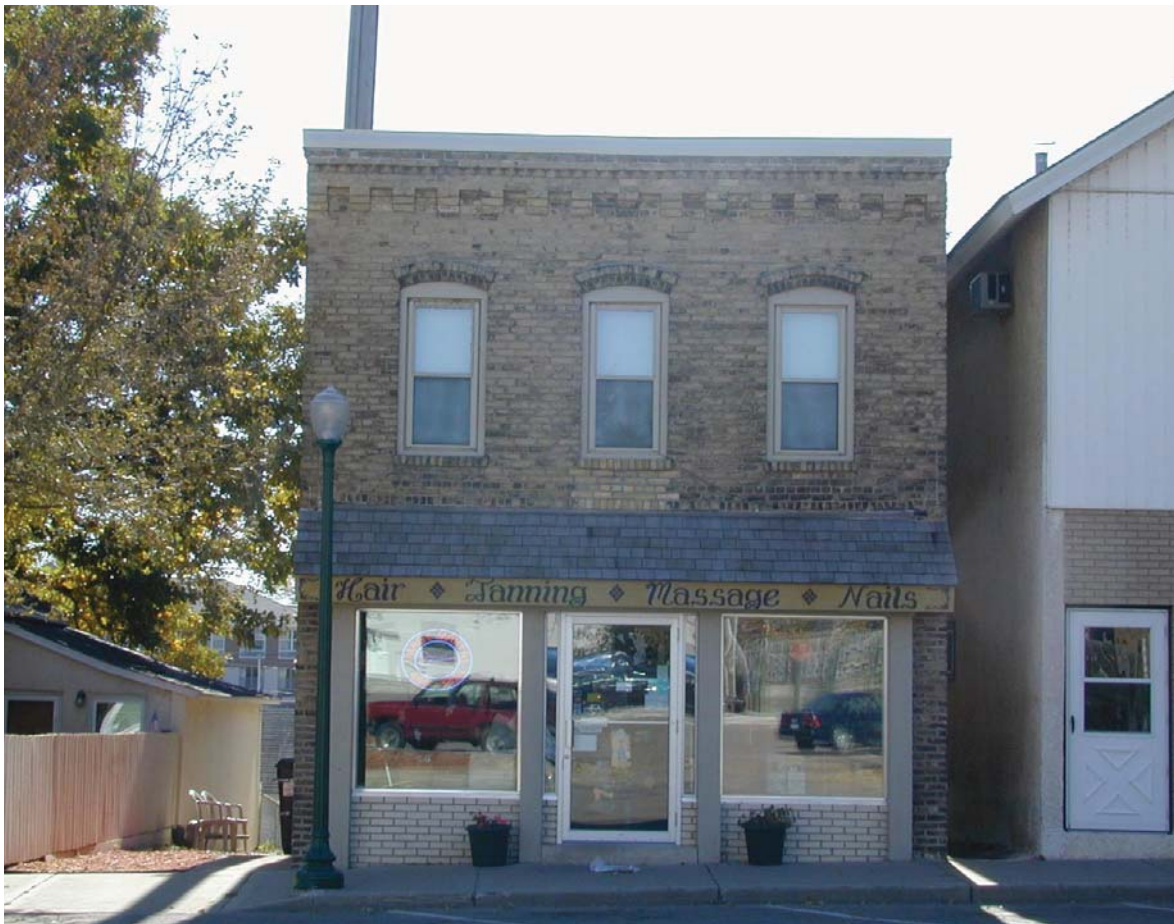
Existing Condition

- Existing wood windows on upper story appear in good repair, and storms have been painted to match.
- Face brick is clean, and most mortar is in good repair. Selectively tuckpoint mortar in cornice area to prevent moisture penetration.
- Original storefront display window and transom arrangement have been infilled with modern materials. First floor storefront trim and decorative pilasters are surface applied.

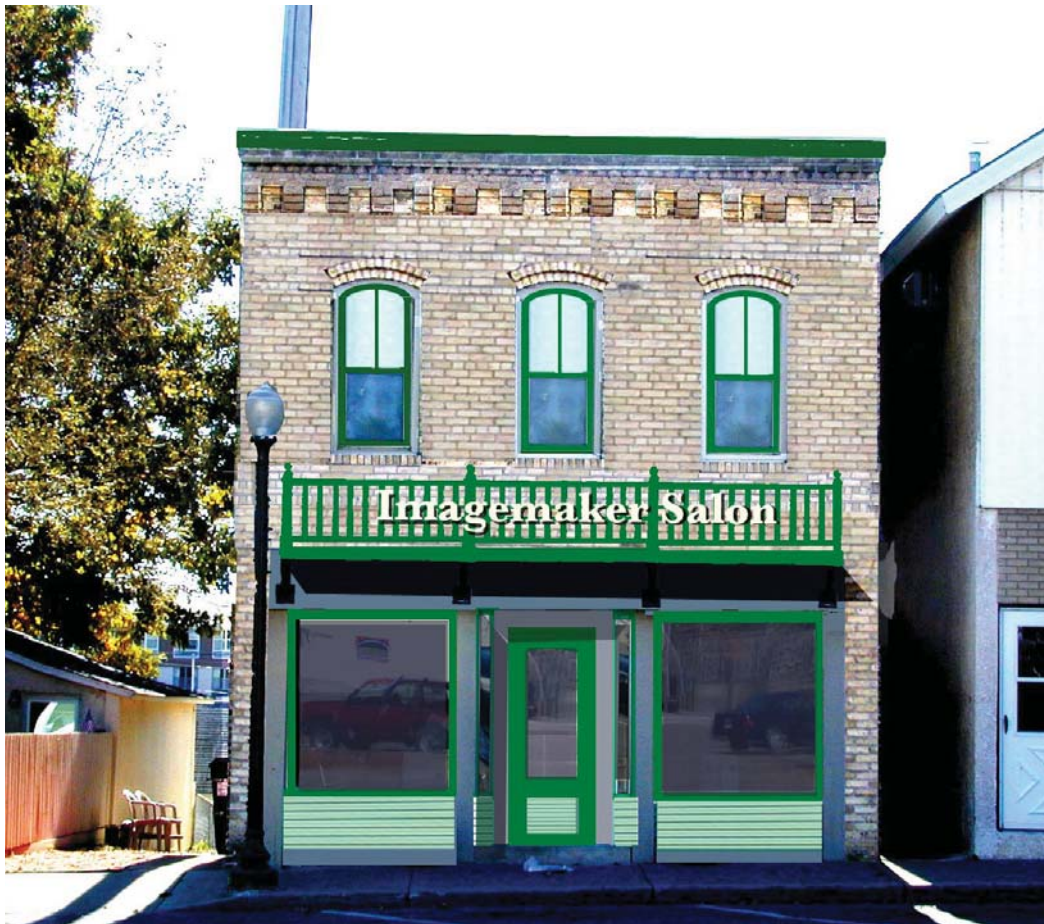
- Inspect roof and back side of parapet. Recently-installed parapet cap flashing is an excellent example of how this work should be done on other historic buildings.
- Original storefront display window and transom arrangement have been infilled with modern materials. First floor storefront trim and decorative pilasters are surface applied.
- Paint or replace glass and aluminum storefront. Replace glass-and-aluminum entrance door with more historically appropriate materials, slightly recessed as shown on the proposed renovation concept.
- Paint trim board where pent roof awning has been flashed into original brickwork.

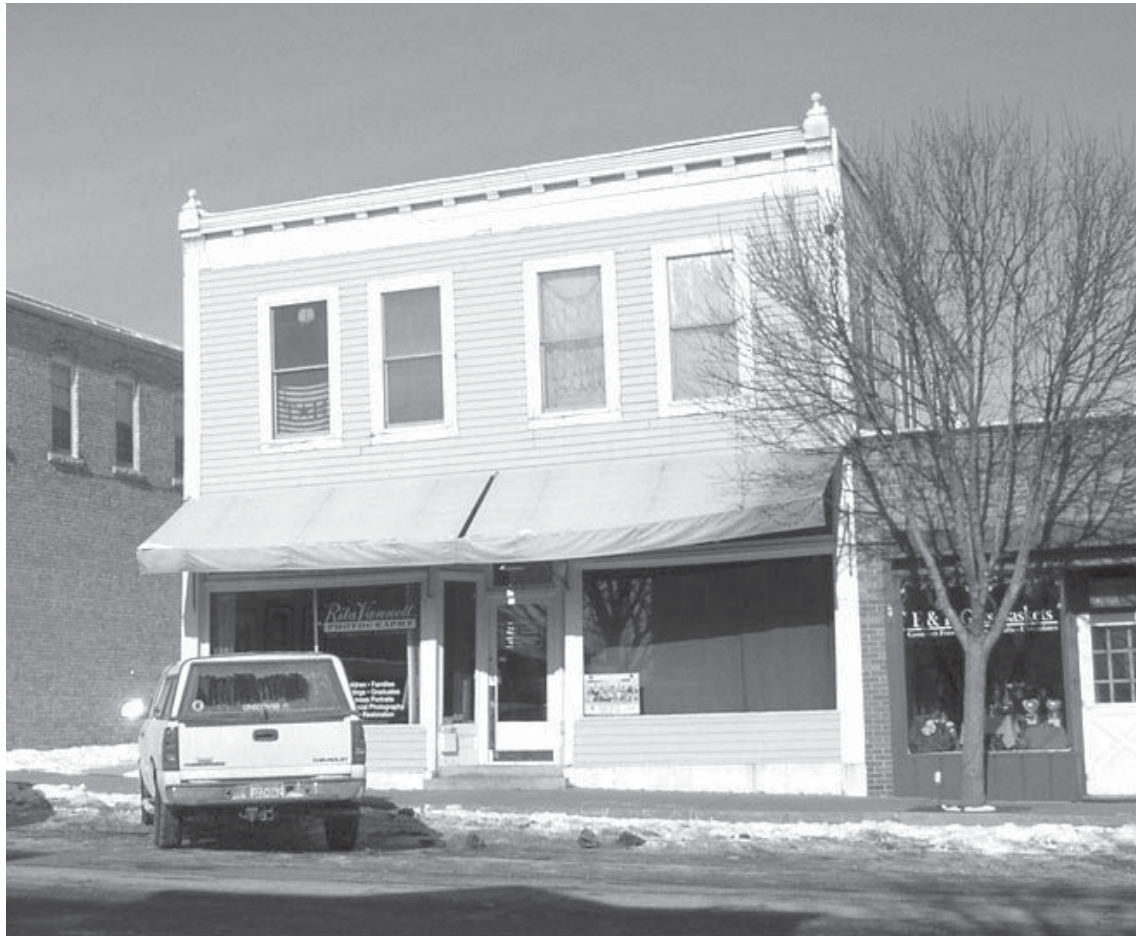
Existing Condition

- Metal cornice is an excellent, historic decorative feature of this building, which could serve as an example for other buildings in the historic downtown district, such as the Red Wing shoe store at 212 Chestnut.
- Overall, this building exterior is in very nearly original condition. Transom and storefront arrangements have been excellently maintained, providing an example for other buildings in the district.

- Paint window trim that appears to have been recently installed on west sidewall openings.
- Touch-up, lightly patch, prime and paint the cornice metalwork to maintain it in good repair.
- Color scheme for building exterior is very subtle and neutral. If canvas retractable awning fabric is replaced, it would afford an opportunity for more accent color and more visible tenant signage.
- Lap siding (upper story front façade and bulkheads) appears to have been replaced with a substitute material that is less durable than original (seams and splices clearly visible).
- Replace lap siding with new redwood or cedar, with 4 1/4-inch exposure. Prime and paint. A slightly deeper and less reflective base color would conceal imperfections in the siding.
- Repair and repaint upper story window trim, especially at four front-window sills which are weathered significantly.

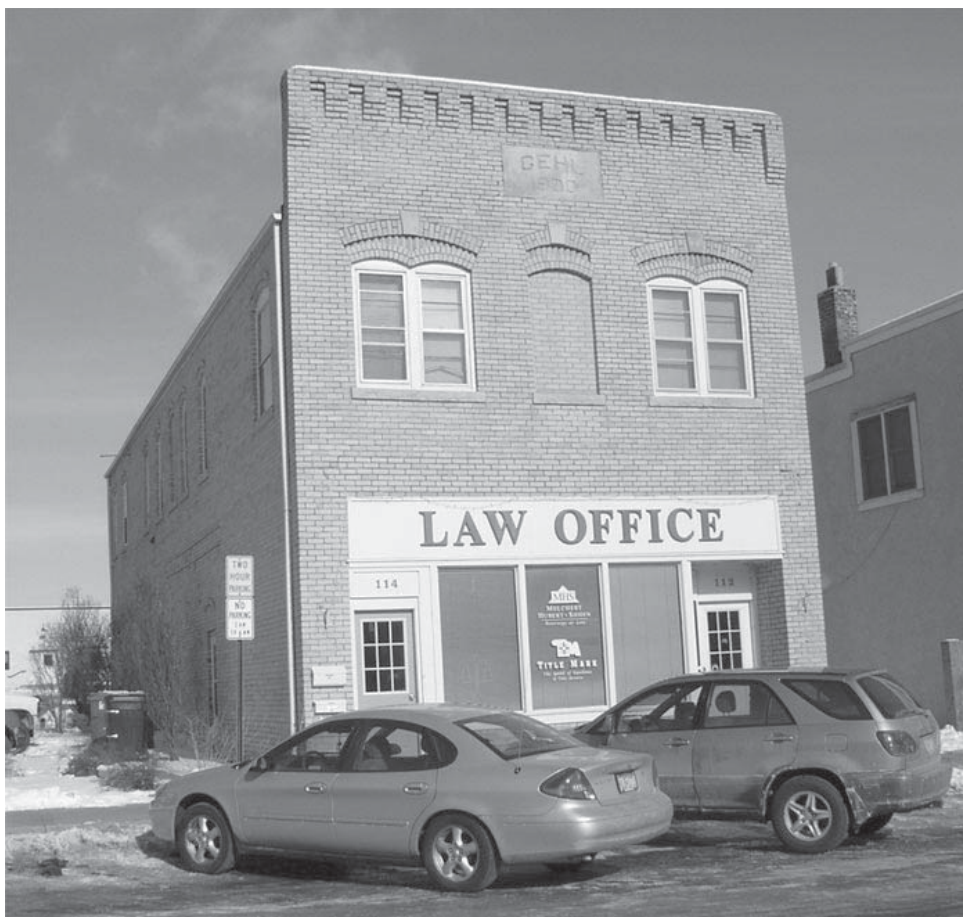
Existing Condition

- Focus of the field survey was on historic exterior features that contribute to the public context, but a brief tour of the building interior showed that the building owners have done an excellent job of retaining historic elements (foundations, side service access doors, etc.) while accommodating new functions.

- Upper story stone sills are in good condition.
- Building exterior has been previously sandblasted, but somewhat more lightly than other buildings in the downtown district.

- Mortar joints are in generally good repair, but any spot repointing of brickwork should take into account the color match of historic reddish mortar.

- The current Law Office business use has done an excellent job of "showing pride" in preserving features of the building's interior historic fabric and capturing the building's heritage through historic photographs. Interior features include an attractively handled service door along the east wall and preservation of the granite fieldstone foundation wall. The building's owners have observed a tendency of soft mortar in the foundation wall to "chalk" or produce dust.

- Upper story storm windows will harmonize better as part of the overall façade if they are painted rather than natural aluminum. Consider a two color, accent paint scheme, which would accentuate the decorative brick arches over upper-story front windows.
- Center egress opening on the upper story is shown by historic photos to have been bricked-in very early in this building's history, so the infill is now part of the building's historic fabric. The brick panel could be re-opened, a "false window" substituted for the brick, or the brick could be left in place to reflect changes in the building's use over time.
- Transom area has been reserved for large building sign. The south orientation of the building front seems an ideal opportunity for a canvas awning which could improve interior comfort and energy efficiency.

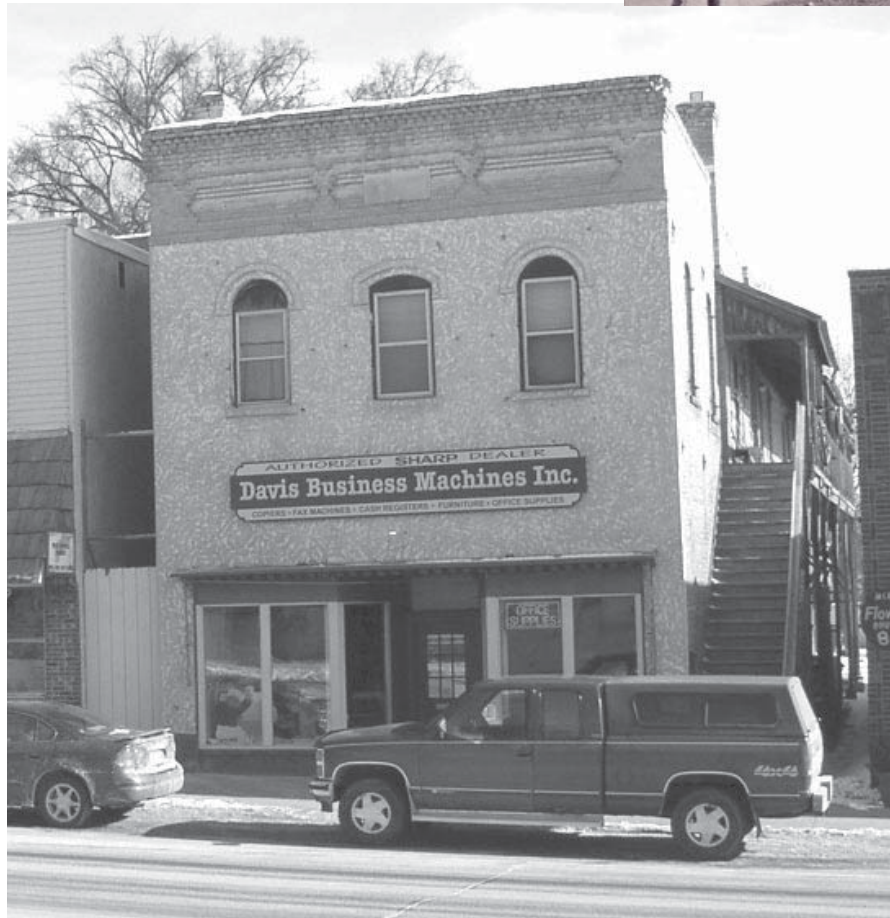
Existing Condition

- Physical evidence suggests that side windows (south wall) originally had operable shutters.
- Retain the cast-iron masonry reinforcement brackets and highlight them as ornament under the renovation concept.
- Oversized, modern sign dominates the façade. Transom area above display windows has been covered with panels and signage. Coordinate with proposed renovation concept for a more unified storefront treatment.

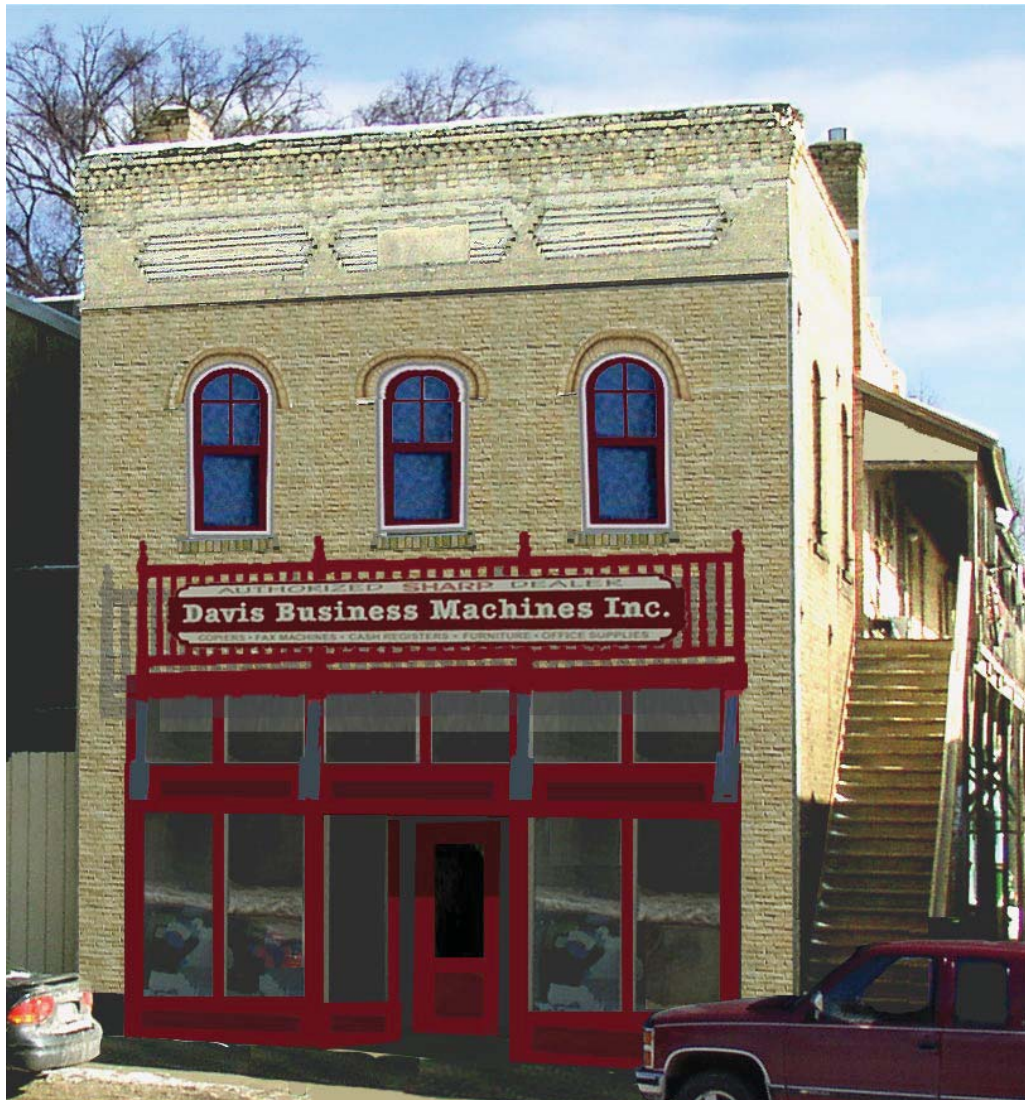
- Repair and tuckpoint brick masonry at parapet. Repair or replace cornice cap for weathertightness.
- Original brickwork has been covered with stucco. In the near term, stucco could be painted a more neutral color, but longer-term, removal of stucco would allow the historic character of this building to be recaptured.

- Ornamental arched window hoods on upper story have been obscured. Repair brickwork over openings.
- Upper windows have been replaced with smaller windows that do not match historic character of the building. Three “bow-top” windows on west façade should be highest priority for replacement.

- Replace windows on upper story, front and side walls with replacement sash to completely fill the masonry openings.
- Replace canvas awnings consistent with historic character of the building, using the awning treatment at 214 Chestnut as an example. Existing retractable awning framework can be reused. Add a new layer of counterflashing over the cap flashing that exists just above the awning.

- Existing storefront materials could be retained if another layer of wood trim is added to the storefront framing and if the color scheme of storefront trim is “punched up” with accent color.

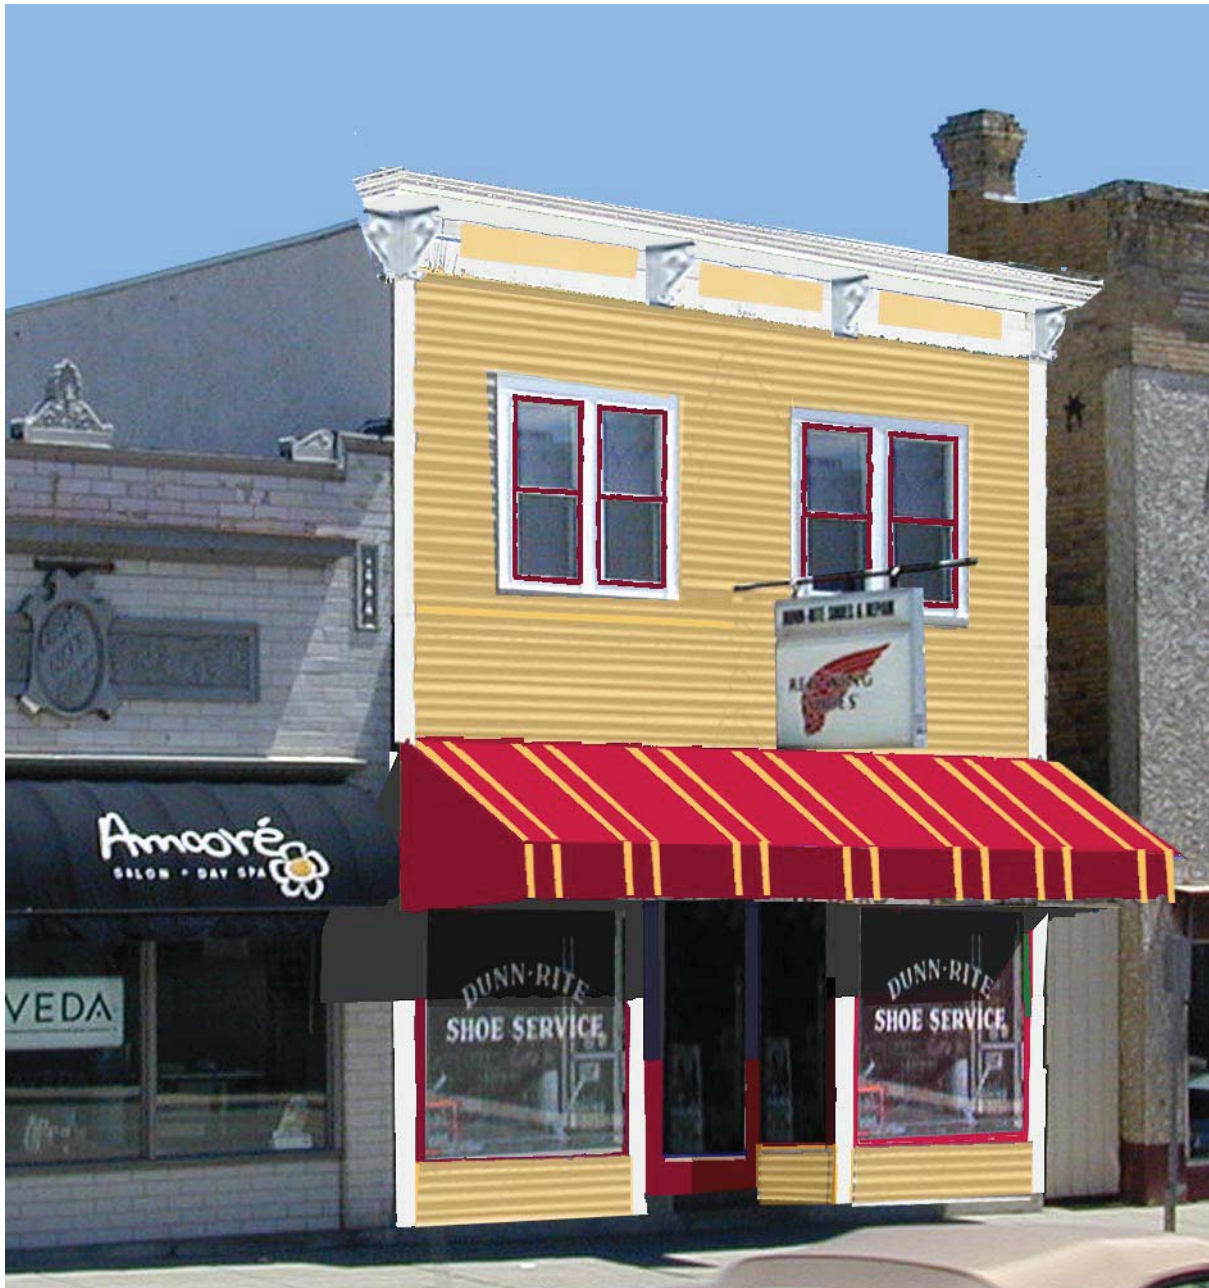
- Fabricate and install new galvanized sheet metal to replicate historic photos.
- Upper story original materials are in generally good condition.
- Remove projecting pent roof canopy which is not appropriate to the historic period of this building. Replace with siding materials to continue upper story treatment down to transom line. Brackets remain visible providing evidence that an historic awning once existed on this building.

- Numerous and varied signage, much of it backlit plastic, results in visually disruptive entrance treatment. The projecting "Red Wing" sign is effective and borderline historic. Reuse it, and organize other signs in a more unified storefront concept.

- Uncover and restore transoms above display windows. Existing brickwork in bulkhead area could be painted to more closely match the color palette of Chaska brick.

- In a mid-term, medium priority, consider new storefront display window configuration to more closely replicate the historic three-bay storefront arrangement.

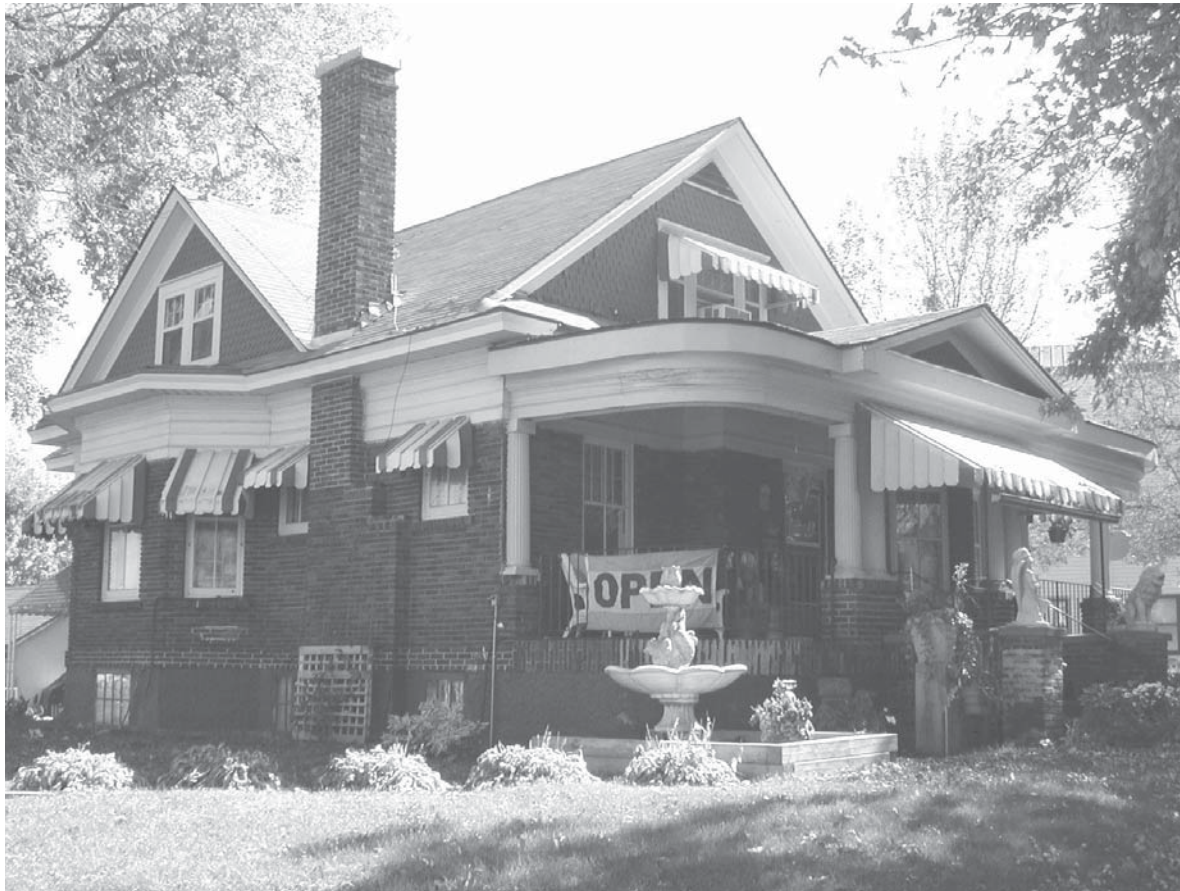
Existing Condition

- This property exhibits an unusual, eclectic combination of Arts & Crafts/Craftsman style architectural features, combined with Classical Revival columns and ornament on the deep wrap-around porch.
- Deep roof overhangs and fish-scale shingles are decorative highlights for the dark reddish-brown blend of brick, which is unusual in comparison to the cream-color most associated with brick production in Chaska.

- Accent paint colors would brighten up the exterior and call attention to architectural details like the fish-scale shingles and window trim.
- Remove existing lightweight awnings which obscure roof form and window openings, especially over the west-facing entry stair.
- A new porch rail is proposed, consistent with horizontal character of the wrap-around porch. This feature could be confirmed by historic photos of the house, but in any case seems more architecturally consistent with the porch than does the slender wrought iron railing that exists there.
- Inspect and repair flashings and shingle roof, particularly in the areas of many roof and porch intersections.

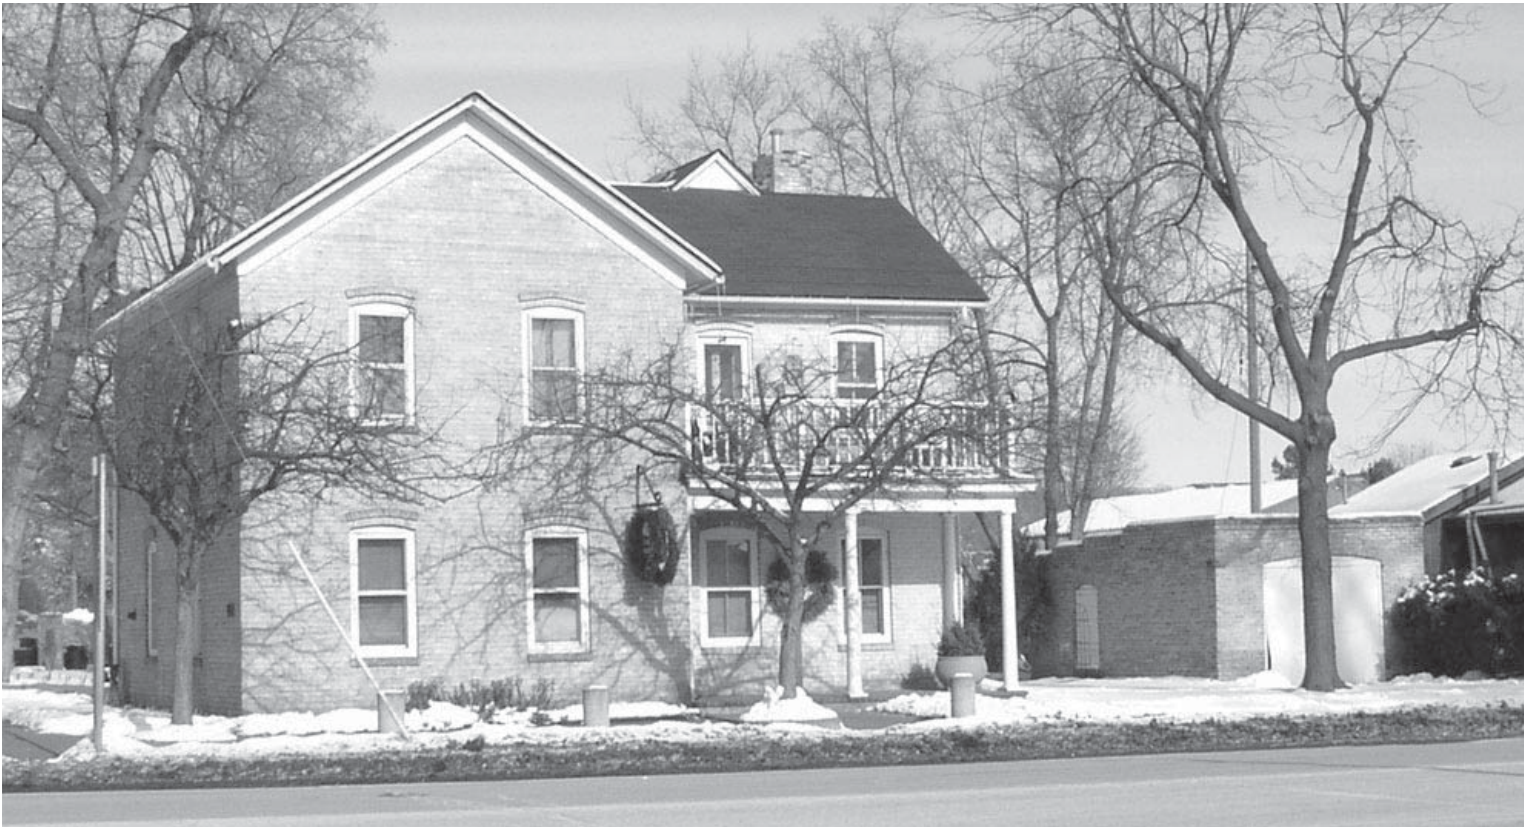
- Exterior brickwork is in original condition and in excellent repair.
- Asphalt shingle roof, gutters and fascia trim are all in good repair.
- Projecting arched window hoods are an ornamental feature of this vernacular building.
- Front porch posts and upper porch railings are in good repair and painted an appropriate "cream" accent color.
- Upper porch, porch railing, doors, and windows all in good condition.

- Existing windows and storm sash afford good sound control from busy US Highway 212 traffic noise.
- Original windows in some openings show the profile of historic windows to have been “2 over 2” glazing pattern. This could be highlighted with an accent color paint scheme.
- Interesting opportunity exists for landscape development to the east, possibly with a trellis connecting to the former garage, to “showcase” the design expertise of the landscape architecture firm currently situated in this property. Current property owner is mindful of potential to use old garage as an accessory conference room.
- Inspect roofing and flashings for former garage outbuilding.

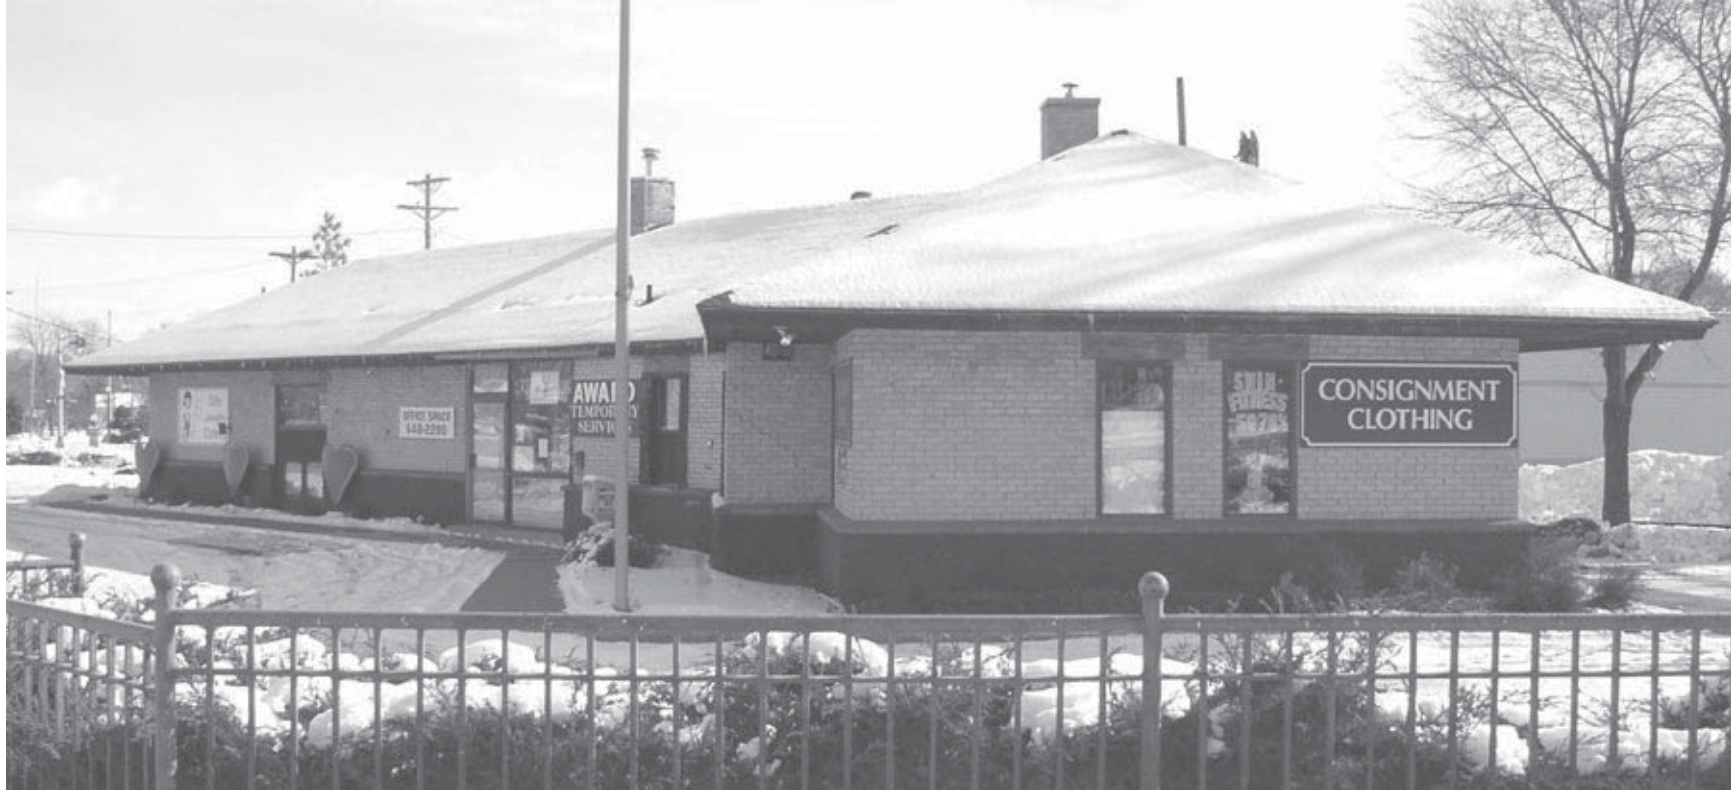
- North-facing public entrance is clearly non-historic (anodized aluminum entrance system), but its configuration external to the historic brick fabric of the building deals with the requirements of a weatherproof vestibule in a generally successful way. This arrangement could be emulated in other, more sympathetic materials.

- Nice sandstone lintels exist over openings, protected by the roof overhangs.
- Site work: Signal semaphore is an important interpretive feature that has been preserved.

- Brick on this building shows distinctive manufacturing impurities in original clay body, comparable to two livery stable buildings in the downtown district.

- If this property is to be used for a public, City-owned function, issues of ADA-accessible entry would need to be addressed.
- Bowed roof sheathing appears to have failed in several locations.

- Inspect and repair soffits, fascias, and gutters. Replace diverter gutters over entrances. Edge flashings appear to be relatively intact.
- Replace rough-sawn soffit material with beaded board more consistent with historical period of the building.

- Replace aluminum doors and surrounds with glass-panel (painted) wood doors. Coordinate style of all entrance doors on this building.
- Property is a candidate for overall window replacement. Window treatment that was used to fill in freight doors toward east end does not satisfactorily match historic character of this building.

- Recess new windows back from the face of brick.
- Re-build chimney cap to discretely accommodate mechanical vent.
- Masonry below the watertable course has been covered with rough-finish stucco and painted a dark brown color. Repair and repaint stucco a lighter, sandstone color to coordinate with stone cap.

- Caulk or repoint joints in sandstone watertable.
- Coordinate with railroad company to install grade-level pedestrian access from south. Consider installing a short section of rail for potential interpretive railcar (brick car?) on diagonal orientation parallel to the southwest entrance.

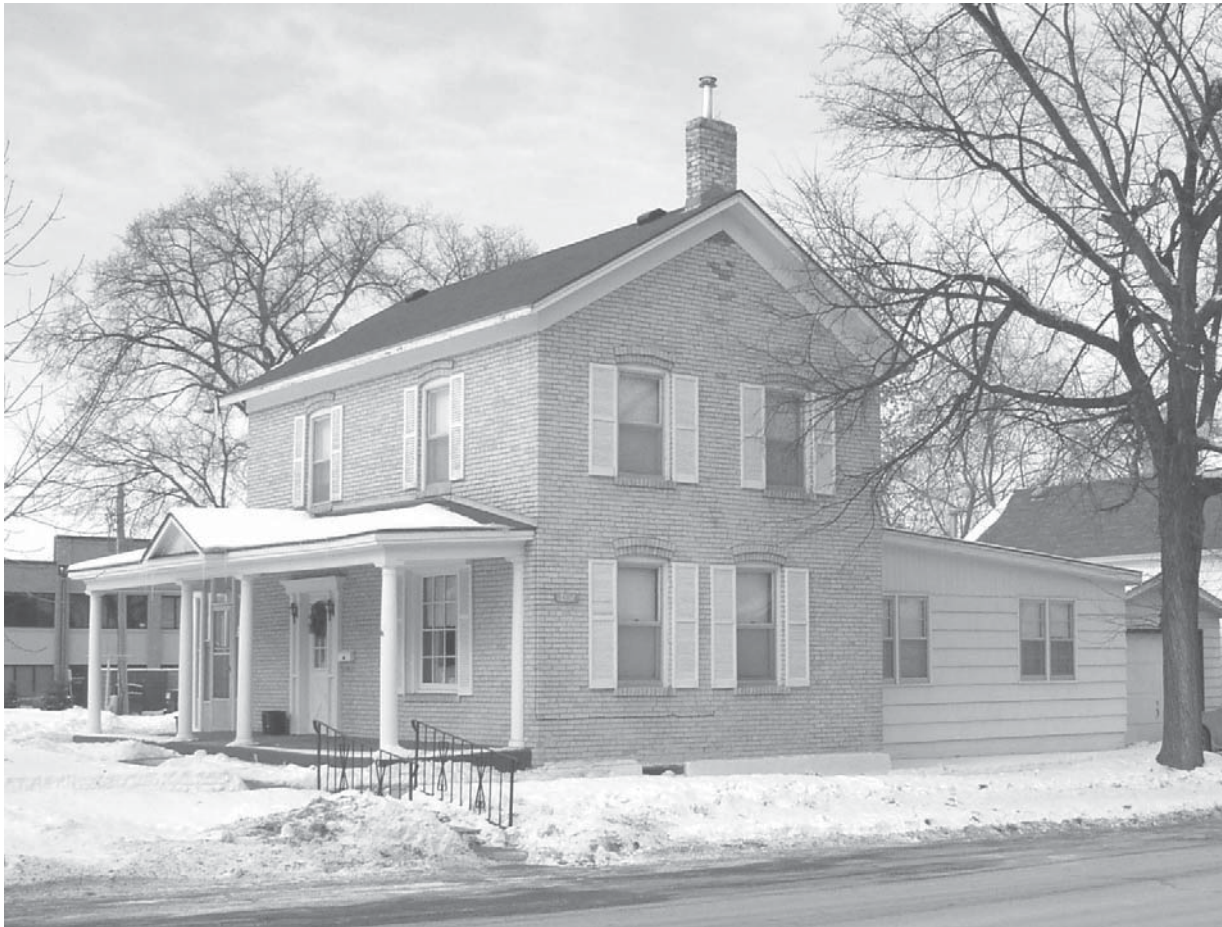
- This residential property is in excellent, nearly original condition, thanks to remarkable ongoing effort to maintain the property.
- Flashings on the porch are especially well-executed.

- Window shutters should probably be modified to more closely match the original appearance, by adding radius tops to the existing wood shutters.
- In the long-run, consider re-framing the roof of the rear (north) framed addition to be a gable perpendicular to the main part of the house. This could be done without intruding on existing north window openings and would eliminate drainage problems toward garage of property to the north..

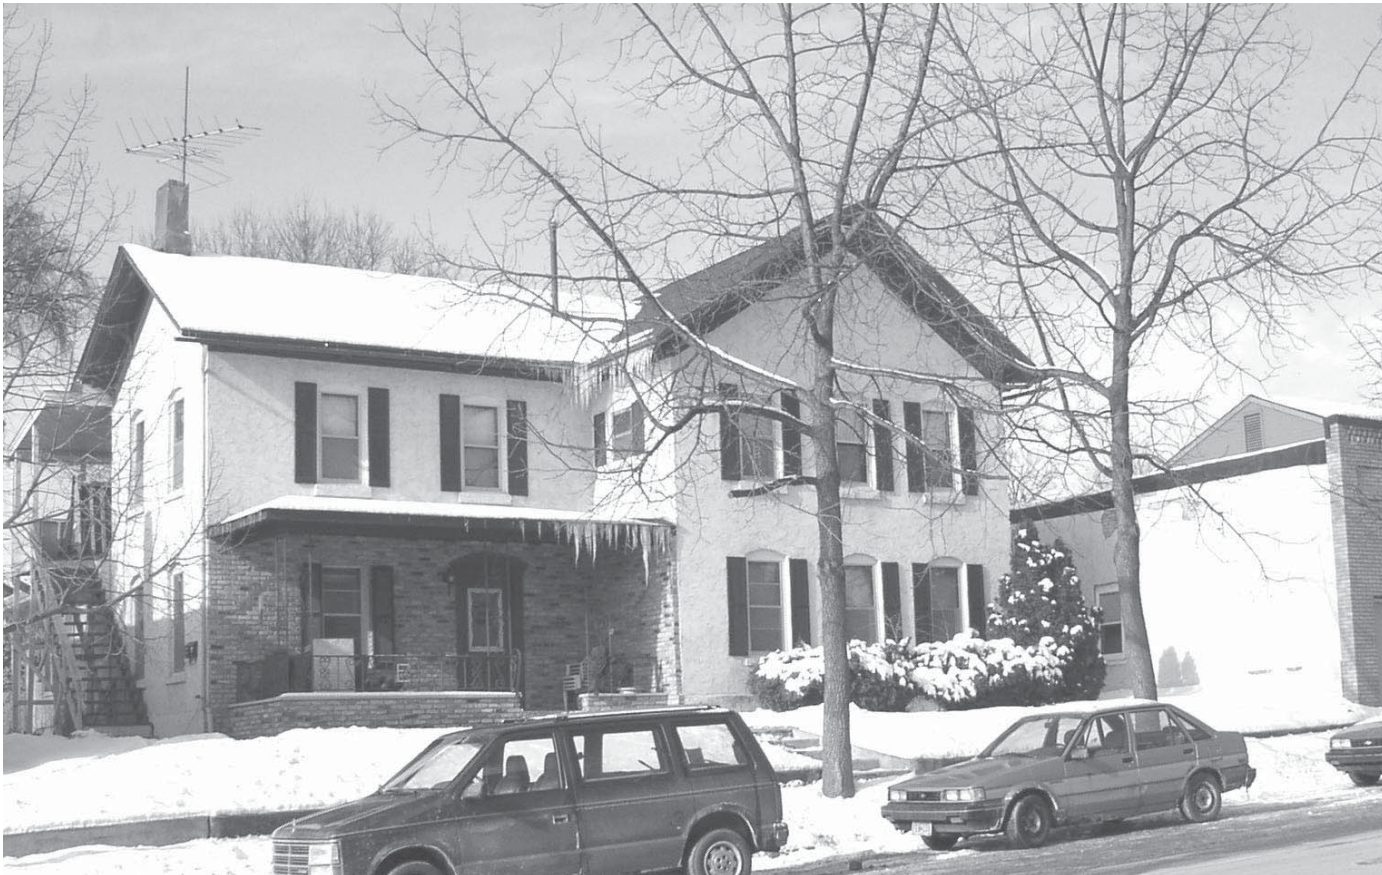
- Historic porch structure exists intact at rear of house.
- Building has been covered with thin layer of stucco that could be stripped, with masonry underneath repaired.
- Existing window shutters are historically inaccurate. Replace them with shutters to match the width and radius-top window openings.

- Repaint all trim a lighter color, with paint accent scheme to emphasize the nice roof edge brackets. Retain the historic half-round drainage gutter wherever possible.
- Remove stucco. Repair and repoint masonry and mortar underneath.
- Reconstruct front porch to more accurately match historic details of 1880 period. Although photographic evidence has not been located, existing wrought ironwork appears to be lighter and more slender than would be expected on an historic building.
- Replace windows with insulating double-hung sash inserts to match historic configuration.
- Replace shutters to match the width and radius-top window openings.

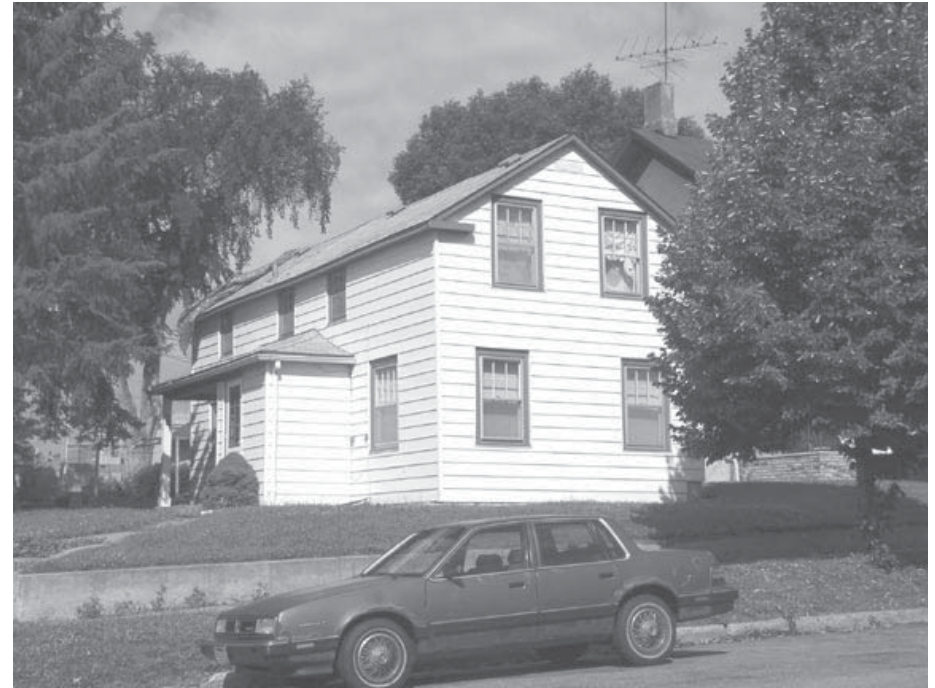
- Building has been entirely clad with prefinished metal siding that is historically inaccurate in terms of material and overlap dimension. Insufficient historic evidence of the building’s original appearance has been found in the form of historical photographs from the Chaska Historical Society, but the width of openings suggest that this was originally a frame building rather than brick masonry.

- “6 over one” window sash profile and window trim are consistent with the historical period, although original openings may have been taller and narrower. Repaint window trim in historical color scheme, with accent colors at openings and trim.

- Because this property has been so drastically altered, a “reconstructed” view has not been proposed as part of this study. However, the house is a contributing part of the Walnut Street District and may well qualify for major reconstruction at some future time. Replace exterior siding with new, narrower-profile material to more accurately match the texture of a building from this historical period.

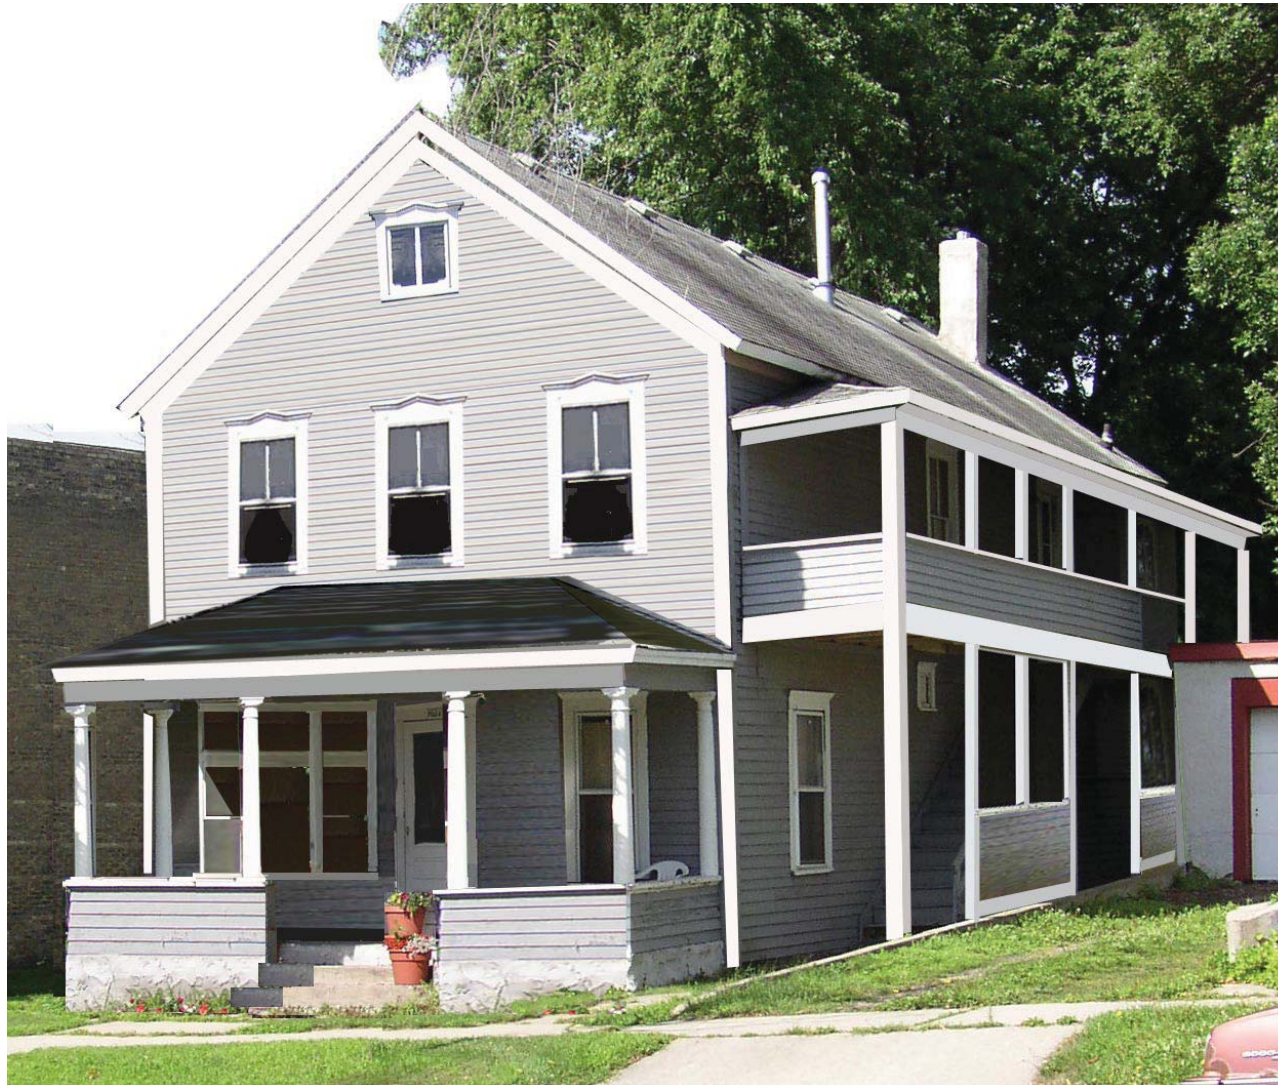
- Front porch has been modified from original condition, but the modifications are consistent with historical change in the building.

- Remove two existing arborvitae trees that are growing too close to the building façade, and remove one dead boulevard tree.
- Repair or reconstruct framed porch on north side. (Visually, the upper porch remains intact in very nearly original condition. Its details can provide a good “model” for framed porch structures on other buildings in the historic district.) Level the porch and support posts.

- Roof is vented but shingles need repair or replacement.
- Rehabilitate wood windows or retrofit with “2 over 2” replacement sash.
- Protect, inspect, and repair the very nice stained glass transom window.

- Repair and repaint wood window hoods.
- Scrape, prime and repaint existing wood siding. Spot repair bowed siding. Replace deteriorated corner boards and wood trim with moisture-resistant wood to match profile and dimensions.

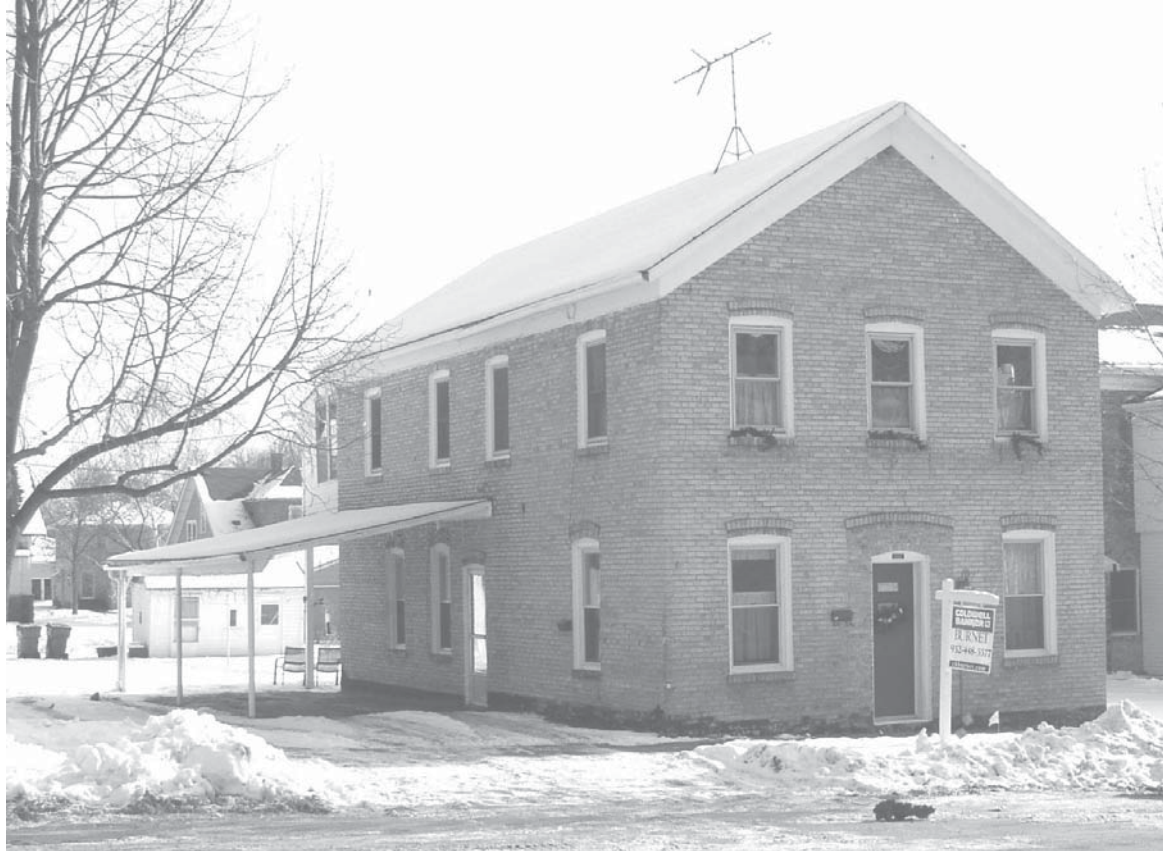
Existing Condition

- Brickwork and masonry exist in generally sound condition. Selectively repoint and repair open mortar joints.
- Replacement window sash has been installed in historic frames. Visual effect is historically accurate.
- An interesting, early-period free-standing brick smokehouse outbuilding exists in back, covered with stucco.

- Existing carport roof inadequately matches historic character of the building and should be removed.
- Visual evidence of black asphaltic coating on bottom three courses of brickwork and black poly sheeting along south wall suggests potential for moisture penetration at grade. Re-grade around bottom of building for more positive drainage away from building.

- Repair and tuckpoint brick at chimney. Repair or replace chimney flashings for watertightness. Repoint and repair brick mortar joints where deteriorated from chimney leakage.

- Replace well-worn asphalt shingle roof.
- Doors and windows exist in relatively sound condition. Repoint sloping brick window sills for watertightness. Repaint brick window “returns” at jambs of masonry openings a neutral cream color.

- Install new storm windows painted in an accent-color scheme as shown to highlight the “2 over 2” window muntin pattern.
- Seal the joint between asphalt parking surface and base of north facing brick wall to prevent moisture penetration.
