FORMER L.W. WELLER BUILDING (1904)
(currently Chaska Family Chiropractic);
103 West Second Street

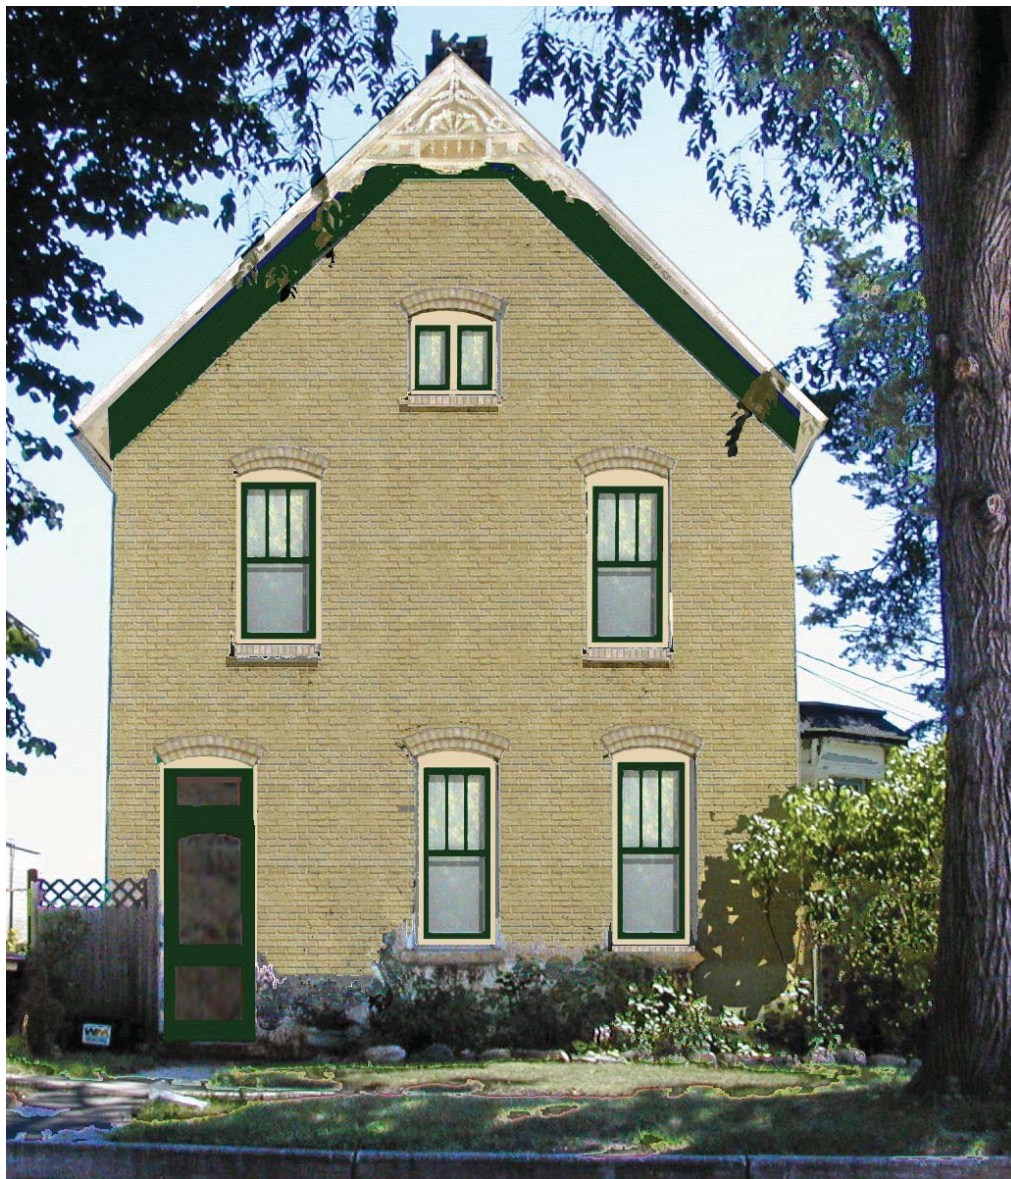
- Within the historic context, this residential property seems to have good potential for redevelopment that would enhance the district.
- Building form and details retain almost all of the house’s historical character (including a projecting bay window on the south elevation), as shown in an early photo from the collections of the Chaska Historical Society.

- Remove thin-coated stucco to reveal details of the brick underneath. Chemically strip paint from brickwork if necessary.
- Install replacement sash windows and storms in a more historic configuration. Use historically appropriate accent colors for storm sash and trim.
- Maintain the transom above the entrance door and install a new, historically-appropriate wood panel door.
- Inspect and replace shingle roof. Rebuild brick chimneys as required.
- Repair and repaint wood trimwork.
- Reconstruct picket fence that shows in the historic photo.

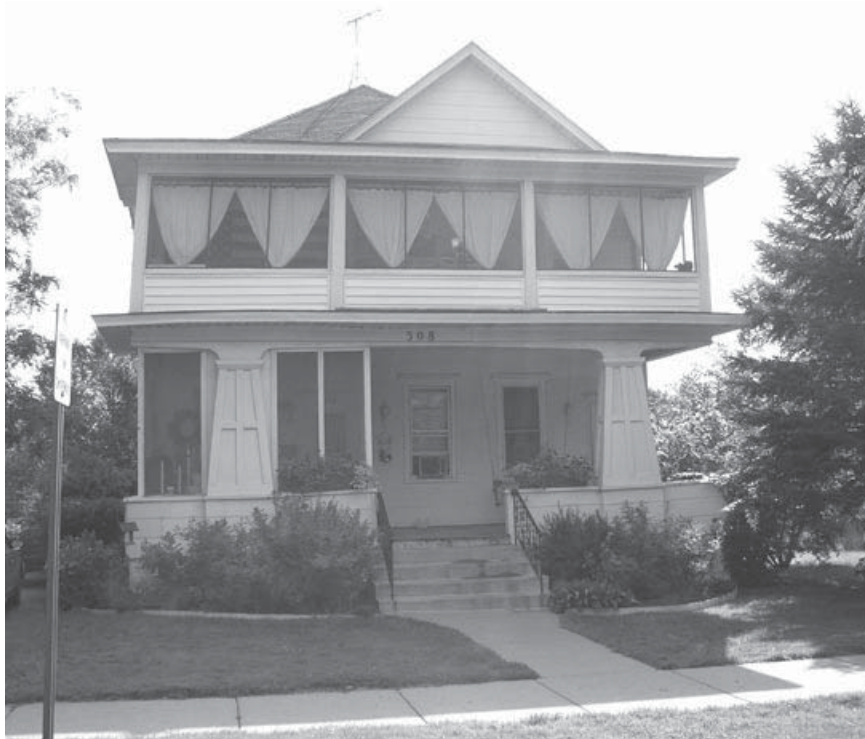
- This building is currently the subject of careful rehabilitation planning on the part of the property owner consistent with the historic character as the house.
- Structural cantilever beams that support the upper porch show signs of distress and settlement. In the course of renovation efforts, a careful structural analysis of the porch structure should be made by a qualified engineer.
