## CHASKA FLOUR MILL (1897)

## Preservation Success Story

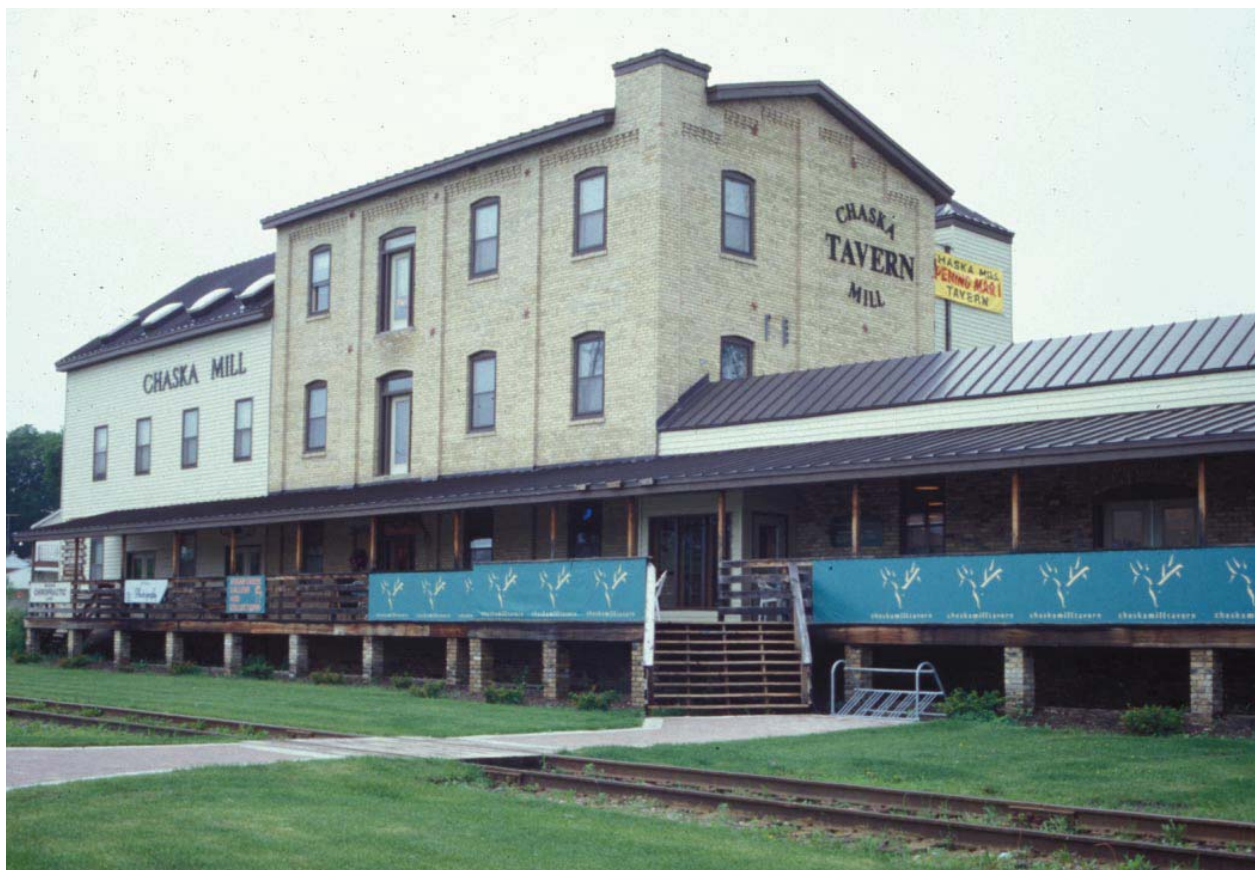
- More reliable, prefinished, standing seam metal roofs have been used in lieu of the corrugated sheet metal that once existed on this building.
- Brick and mortar have been cleaned and repointed, and are in good, sound condition.

- Wrought metal, masonry rod tie caps have been placed and accentuated in a decorative way.
- In the previous renovation of this building, design judgment was to re-build the full-width, side “loading dock” (balcony/deck) in an industrial vocabulary consistent with historic use of the building.

- Cap flashing is loose and unsecured at facing brick that appears to have been added in the lower 8-feet of the west wall. Repair brick and mortar at one, open vertical masonry joint in this area (northwest corner).

- Door openings in the three-story mill part of the building appear to have been permanently secured and made inoperable. An exterior, metal pipe guard rail might also be added at these two fixed openings.

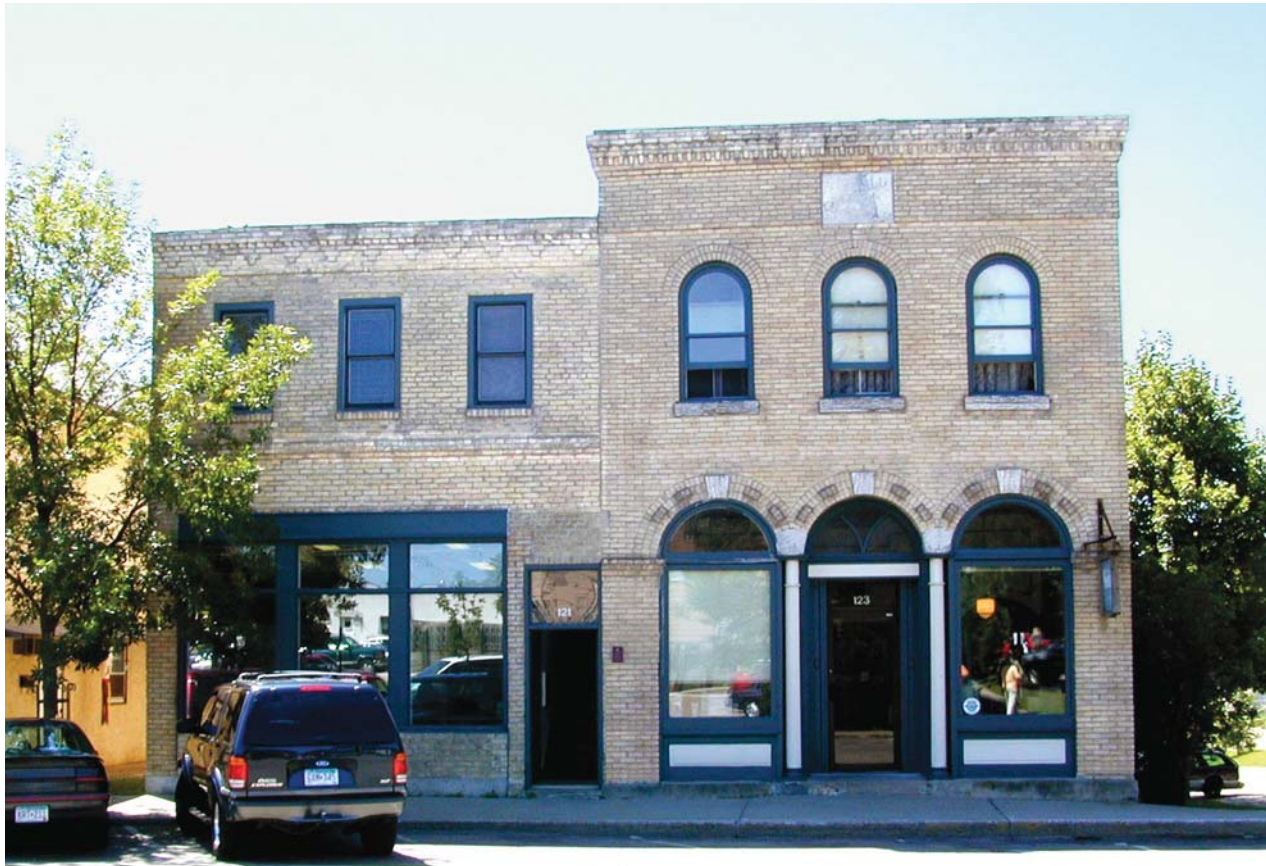
- Building is in generally excellent, sound repair, and well-maintained.
- Inspect roofing and flashings. No cap flashing is visible atop the front façade.

- Limestone sills, arch impost blocks, and building name block are extensively weathered, but good preservation practice does not call for any modification of them.

- Repair parging just below front-façade bulkheads where foundation is becoming exposed.
- Touch-up paint on cast iron columns with rust-inhibitor.
- Condition of all wood-framed elements added to the back of the building is generally quite good. These porch and egress stair additions provide an excellent example for other property owners of how modern elements can be added to an historic Chaska commercial building without detracting from its historic qualities.

- Questionable foundation drainage along west wall sidewalk could be improved with installation of sloped paver materials in place of the plant materials that currently grow on this side.

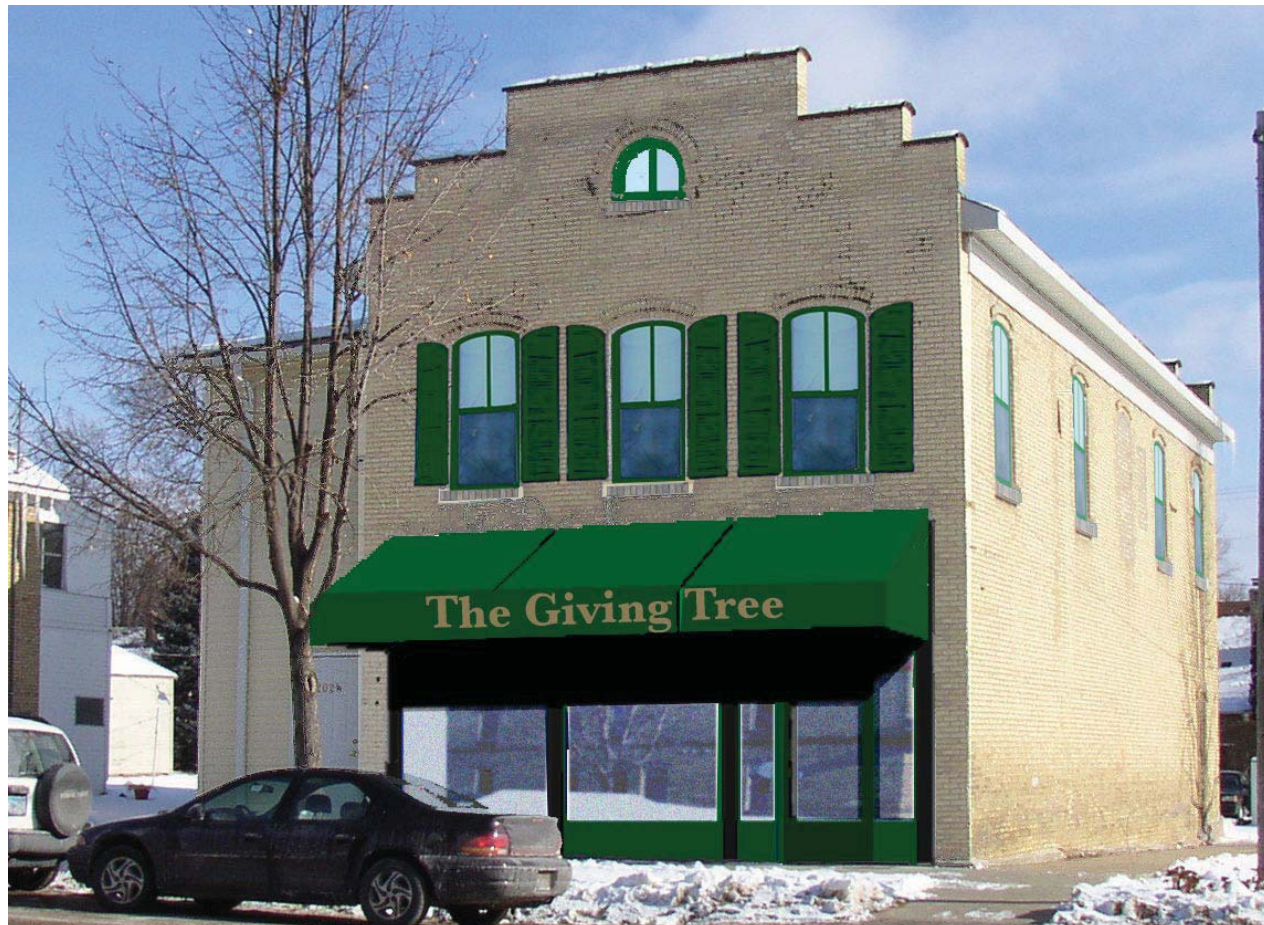
- Some corbelled masonry projections above the parapet line have been removed. A historic photo of this building's original appearance, showing upper story awnings, first floor arched openings, and corbelled brick parapet details is available in the collections of the Chaska Historical Society.

- Upper portion of front façade is intact and in good condition.
- Existing vinyl replacement windows do not completely fill the masonry openings as they would have historically. Replace with sash inserts to replicate the historic profile.

- Some window openings have been partially in-filled with substitute materials to reduce opening size.
- Parging material at top of foundation is installed in a way that does a good, effective job of shedding water away from exterior wall along the south-facing sidewalk. Repair parging in one small area of foundation.

- Limestone sills are extensively weathered and most have been covered with metal panning. This appears to be a satisfactory solution that meets the Secretary of the Interior's Standards for "reverseability". In two locations where limestone remains exposed, there is no critical need for repairs.

- Repair and tuckpoint brick at step-gabled parapets.
- Repair brickwork over one window opening where brick arch has been displaced.
- Replace existing windows with sash inserts to replicate the historic profile.
- Rebuild the decorative parapet cap according to historic photos that show extensive corbelling of the brickwork.

- Spot-clean brick with mild detergent solution, but avoid any form of abrasive cleaning (such as sand- or water-blasting).
- Photographic evidence at the Chaska Historical Society shows that upper story windows originally had arched-topped shutters to match the width of openings on the west (front) facade. Consider reinstalling or reconstructing these features based on the photographic record.

- Consider a strategy of relocating unit air conditioners to the upper part of window openings, and then concealing them on the exterior by using canvas awnings, similar to the way this has been done on the Chaska Bakery.

- Replace vinyl cladding/siding materials on framed structure along north side of building with historically appropriate materials to match the historically accurate details of the side porch.

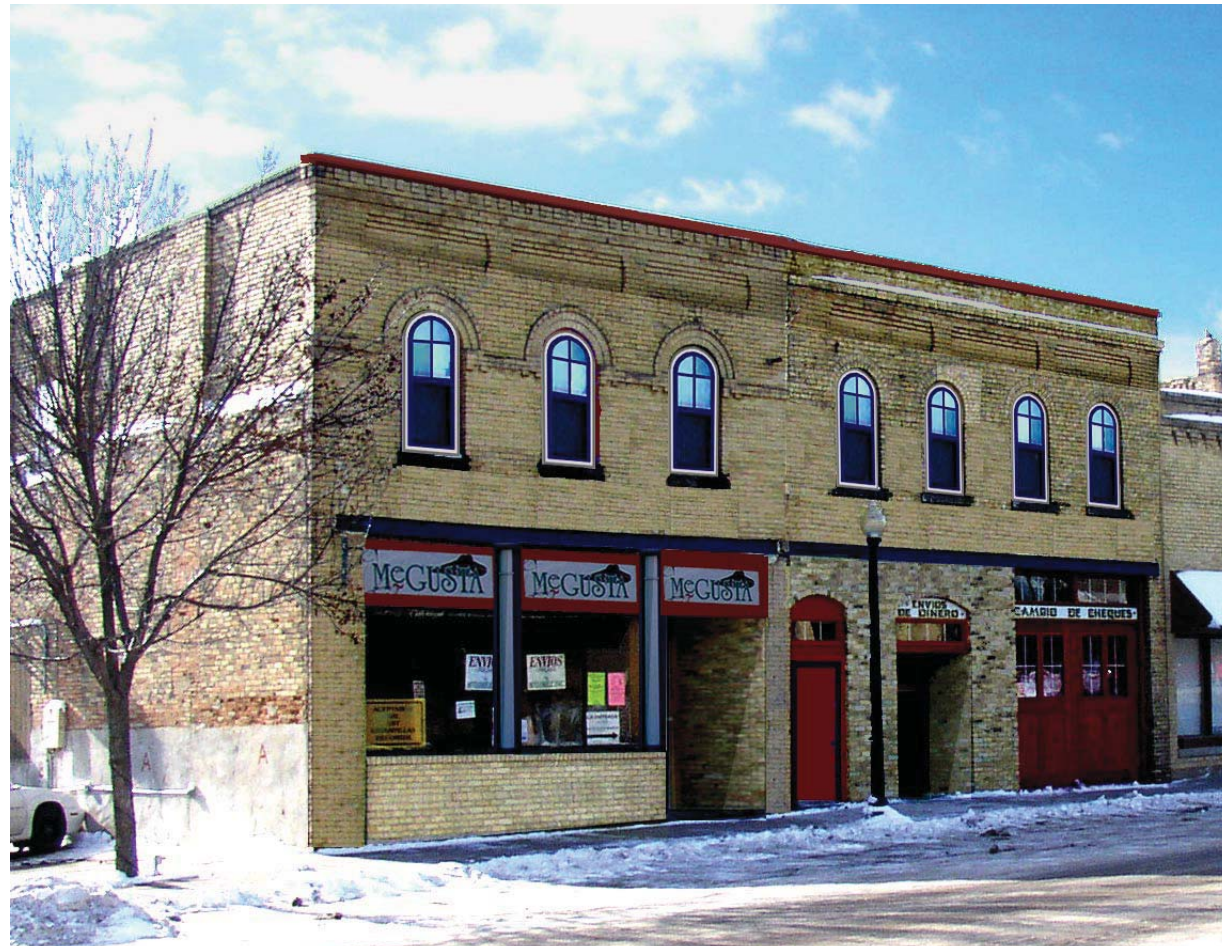
PHILIP HENK HARDWARE BUILDING (1876)  
SUBSEQUENTLY THE  
CHASKA MOTOR SERVICE GARAGE  
(currently McGusta Market)  
*108-110 East Second Street*

- Exterior of this building has previously been damaged by abrasive sandblasting. Otherwise, the brick and mortar appear to be in generally good condition, needing only spot repointing.

- Upper windows have been replaced with windows and infill panel materials that do not match historic character.
- Replace small windows with full-sized, insulated double-hung window sash in historic “radius top” configuration, similar to the Hammer & Beierstettel building across the street.

- Inspect roofing and repair or replace parapet capping (counterflashing) materials for weathertightness.
- Relocate unit air conditioners away from main façade, where they appear to be causing significant moisture problems on the historic brickwork.

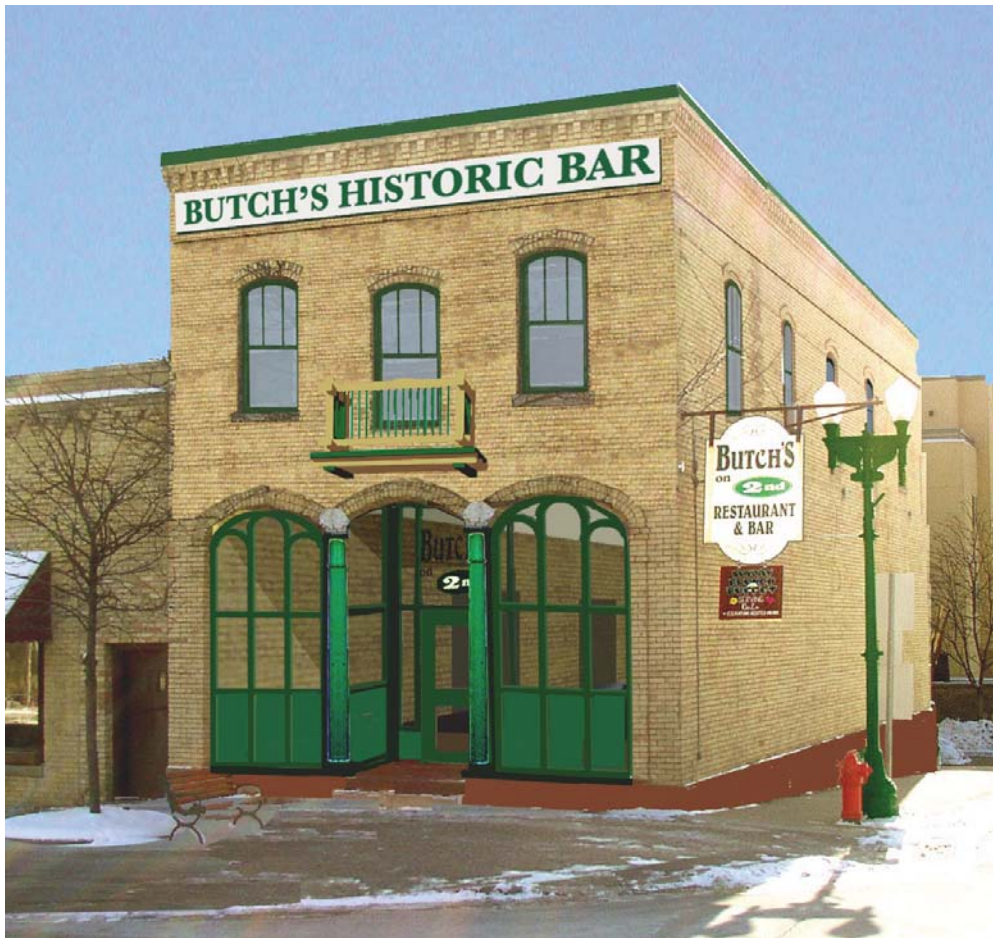
- Exterior of this building was previously renovated and at some time its exterior fabric was damaged by abrasive sandblasting. More recently a major interior fire has displaced the business that operated in this location for many years.
- Because of its association with Chaska's business community for several generations and its prominent corner location, this building is a pivotal property in Chaska's historic downtown district.
- In the aftermath of a disastrous October 2003 fire, a significant opportunity exists for community development resources to contribute toward restoring this pivotal building with such great potential for anchoring the historic downtown.

- Install period-appropriate replacement windows in all openings that have been affected by the fire. Historical photos show “6 over 6” windows on the upper story of this building.

- Reconstruct street-level storefront for more “lightness” and greater transparency.
- Repair parapet cap and selectively repoint brickwork around upper story windows.

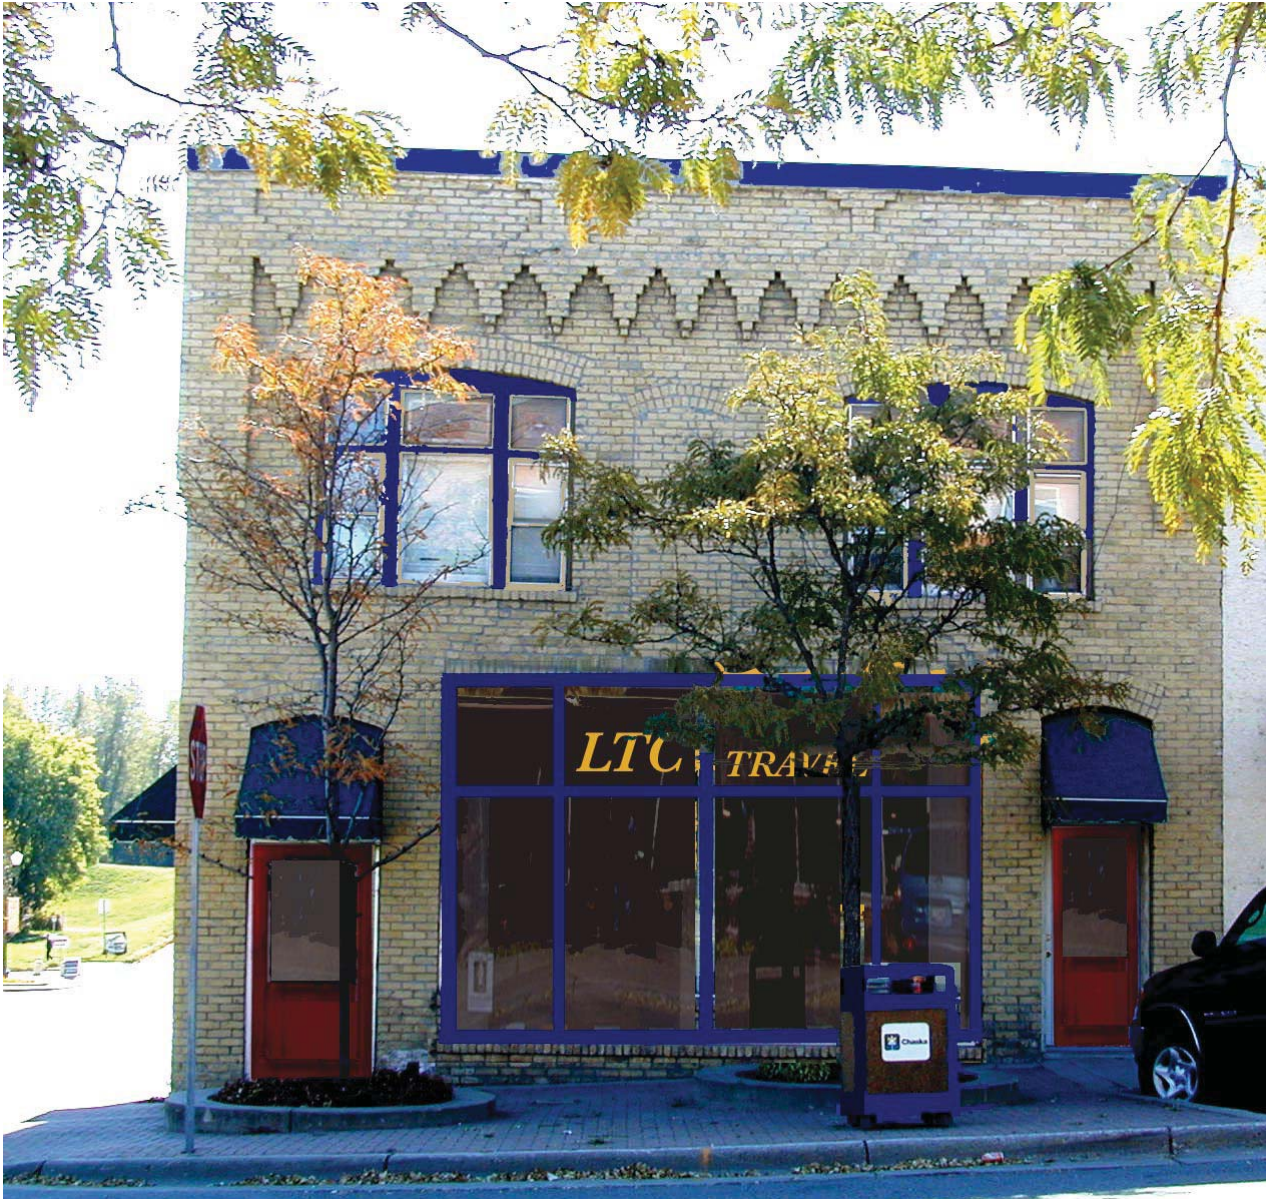
OESTERREICH HARDWARE STORE (1903)  
101 West Second Street

- Elaborate brick corbelling at the cornice line (front and side walls) is an especially distinctive ornamental feature of this building.
- Exterior of this building has previously been damaged by abrasive sandblasting.
- Existing upper story windows suit the historic character of the building almost perfectly. Stained glass in the upper story transom windows is an especially beautiful feature to be preserved.

- Repair cornice cap and cap flashing. This is a serious hazard as it exists, requiring immediate attention. Building tenants were advised that there appear to be loose bricks behind the parapet flashing about to fall onto the sidewalk.

- Previous mortar repointing appears to have been done in a somewhat careless manner, resulting in mortar remaining on the face of bricks. Spot tuckpoint and repair brickwork with lighter-colored, appearance-matched lime mortar.
