FORMER L.W. WELLER BUILDING (1904)
(currently Chaska Family Chiropractic);
103 West Second Street

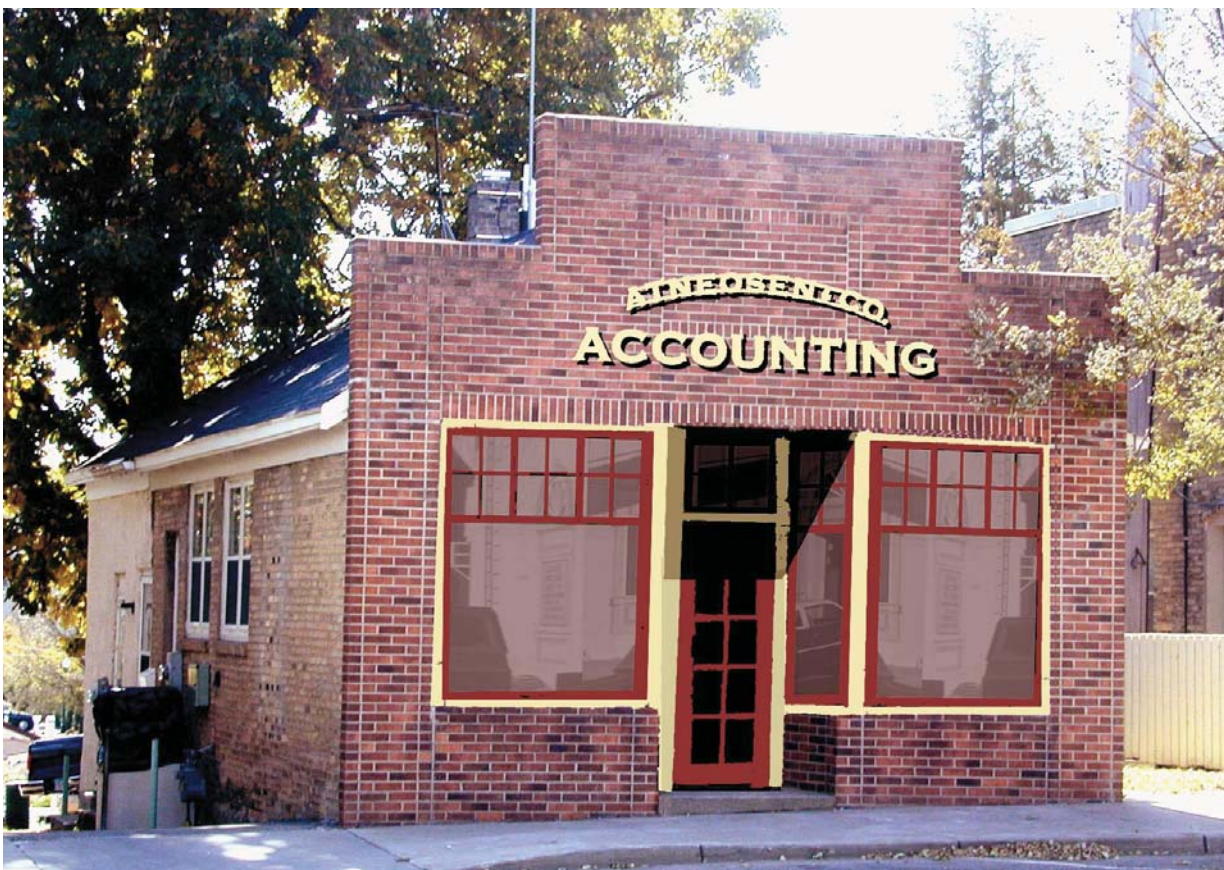
GLATZEL SHOE STORE BUILDING (UNDATED)
(now Larry Atneosen & Co. Accounting);
113 West Second Street

- Repair of eave trim boards was in progress at the time this building was surveyed. Chaska brick on the east side wall appears to have been recently stripped.
- Condition of all exterior materials is sound and well-maintained.
- Existing signage, applied flat to the upper façade, is appropriate, though not historic.

- Historically, the street front elevation would have been a storefront enframed by brick side pilasters and stepped parapet. Red brick façade material is obviously new, but the architectural organization of the front façade is consistent with proportions of historic storefront.
- Paint and reconfigure storefront to unify it according to the proposed renovation concept.

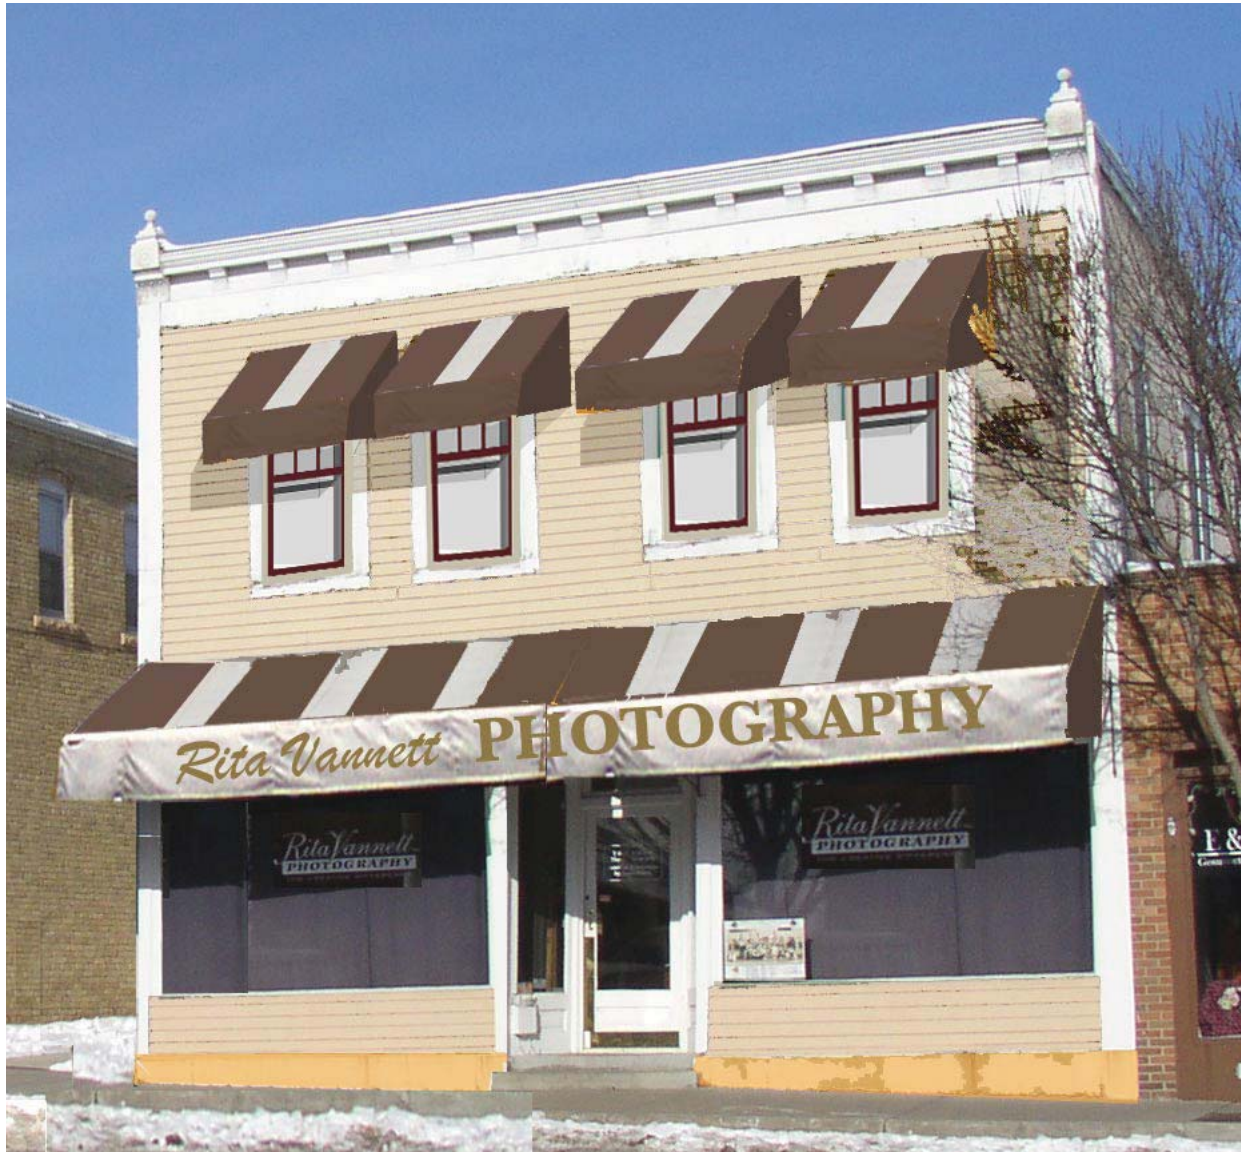
STORE WITH PRESSED METAL CORNICE (undated);
(presently Rita Vanett Photography);
110 West Second Street

- Metal cornice is an excellent, historic decorative feature of this building, which could serve as an example for other buildings in the historic downtown district, such as the Red Wing shoe store at 212 Chestnut.
- Overall, this building exterior is in very nearly original condition. Transom and storefront arrangements have been excellently maintained, providing an example for other buildings in the district.

- Paint window trim that appears to have been recently installed on west sidewall openings.
- Touch-up, lightly patch, prime and paint the cornice metalwork to maintain it in good repair.
- Color scheme for building exterior is very subtle and neutral. If canvas retractable awning fabric is replaced, it would afford an opportunity for more accent color and more visible tenant signage.
- Lap siding (upper story front façade and bulkheads) appears to have been replaced with a substitute material that is less durable than original (seams and splices clearly visible).
- Replace lap siding with new redwood or cedar, with 4 1/4-inch exposure. Prime and paint. A slightly deeper and less reflective base color would conceal imperfections in the siding.
- Repair and repaint upper story window trim, especially at four front-window sills which are weathered significantly.

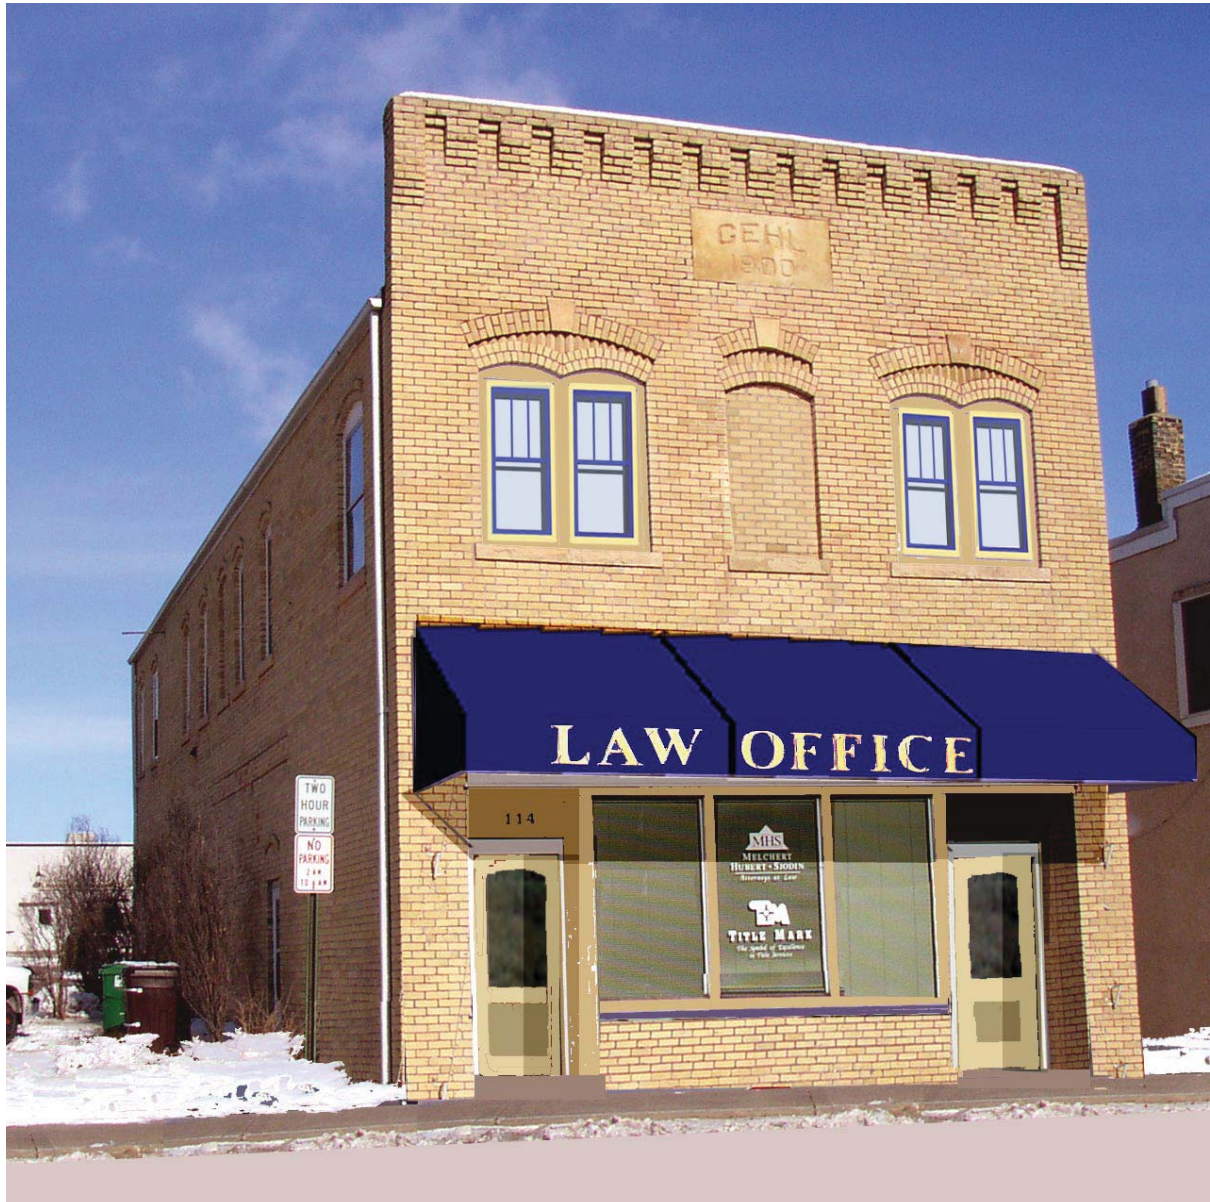
FORMER GEHL'S MEAT MARKET (c. 1900)
(currently Melchert, Hubert, Sjobin Law Offices)
112-114 West Second Street

- Upper story stone sills are in good condition.
- Building exterior has been previously sandblasted, but somewhat more lightly than other buildings in the downtown district.

- Mortar joints are in generally good repair, but any spot repointing of brickwork should take into account the color match of historic reddish mortar.

- The current Law Office business use has done an excellent job of "showing pride" in preserving features of the building's interior historic fabric and capturing the building's heritage through historic photographs. Interior features include an attractively handled service door along the east wall and preservation of the granite fieldstone foundation wall. The building's owners have observed a tendency of soft mortar in the foundation wall to "chalk" or produce dust.

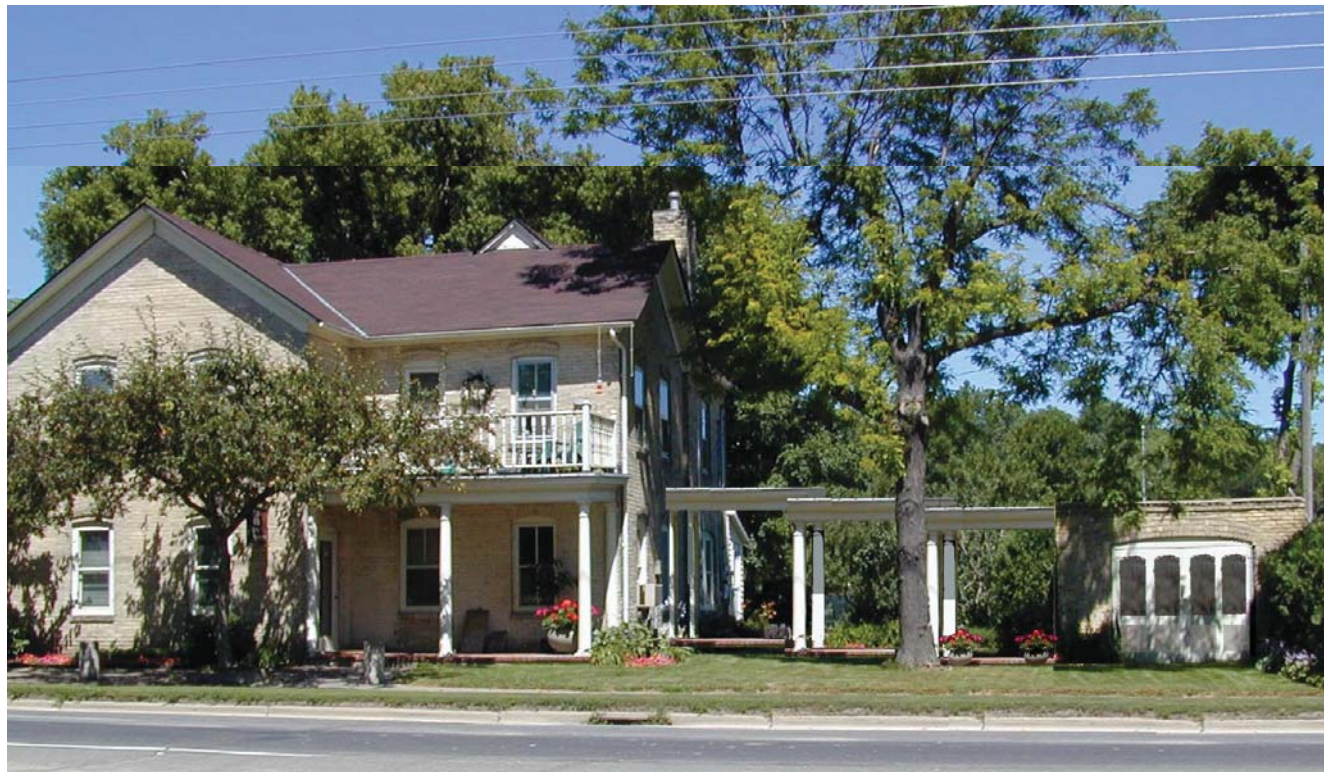
(PHILIP) RIEDELE HOUSE (1884)
(currently Gene Ernst Associates)
122 West Sixth Street (U.S. 212)

- Exterior brickwork is in original condition and in excellent repair.
- Asphalt shingle roof, gutters and fascia trim are all in good repair.
- Projecting arched window hoods are an ornamental feature of this vernacular building.
- Front porch posts and upper porch railings are in good repair and painted an appropriate "cream" accent color.
- Upper porch, porch railing, doors, and windows all in good condition.

- Existing windows and storm sash afford good sound control from busy US Highway 212 traffic noise.
- Original windows in some openings show the profile of historic windows to have been “2 over 2” glazing pattern. This could be highlighted with an accent color paint scheme.
- Interesting opportunity exists for landscape development to the east, possibly with a trellis connecting to the former garage, to “showcase” the design expertise of the landscape architecture firm currently situated in this property. Current property owner is mindful of potential to use old garage as an accessory conference room.
- Inspect roofing and flashings for former garage outbuilding.

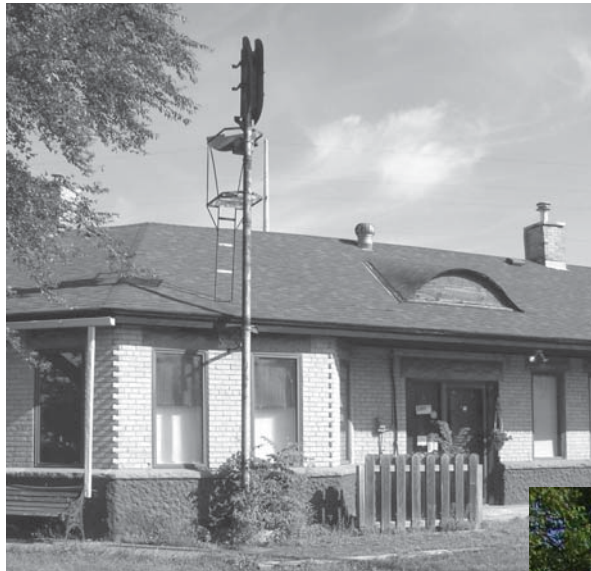
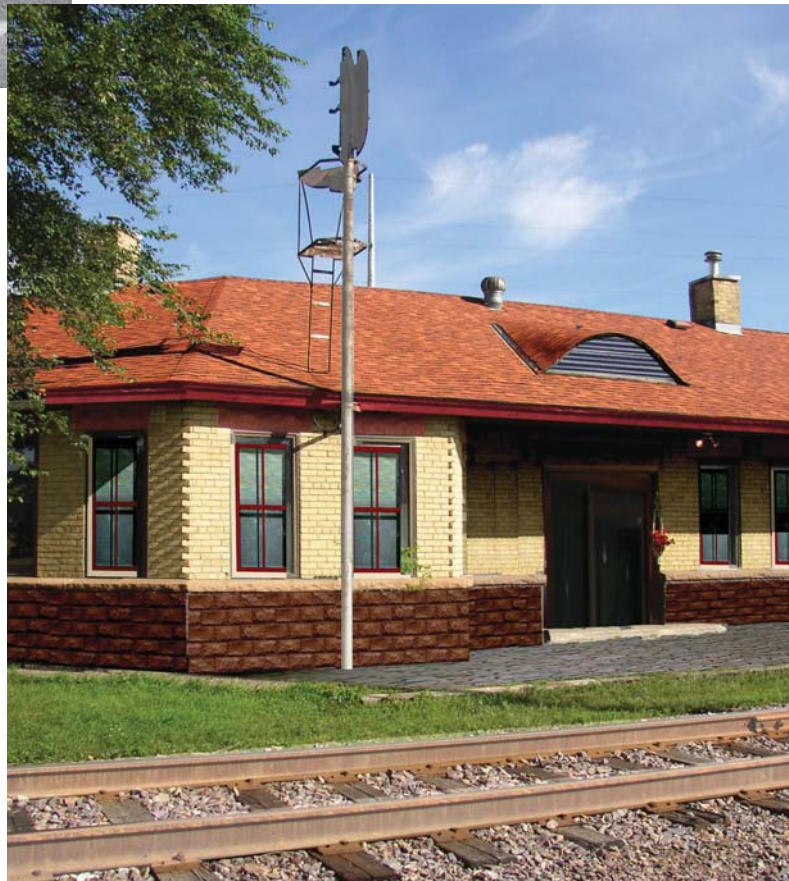
MINNEAPOLIS & ST. LOUIS DEPOT (1911)
101 U.S. Highway 212 East

- If this property is to be used for a public, City-owned function, issues of ADA-accessible entry would need to be addressed.
- Bowed roof sheathing appears to have failed in several locations.

- Inspect and repair soffits, fascias, and gutters. Replace diverter gutters over entrances. Edge flashings appear to be relatively intact.
- Replace rough-sawn soffit material with beaded board more consistent with historical period of the building.

- Replace aluminum doors and surrounds with glass-panel (painted) wood doors. Coordinate style of all entrance doors on this building.
- Property is a candidate for overall window replacement. Window treatment that was used to fill in freight doors toward east end does not satisfactorily match historic character of this building.

- Recess new windows back from the face of brick.
- Re-build chimney cap to discretely accommodate mechanical vent.
- Masonry below the watertable course has been covered with rough-finish stucco and painted a dark brown color. Repair and repaint stucco a lighter, sandstone color to coordinate with stone cap.

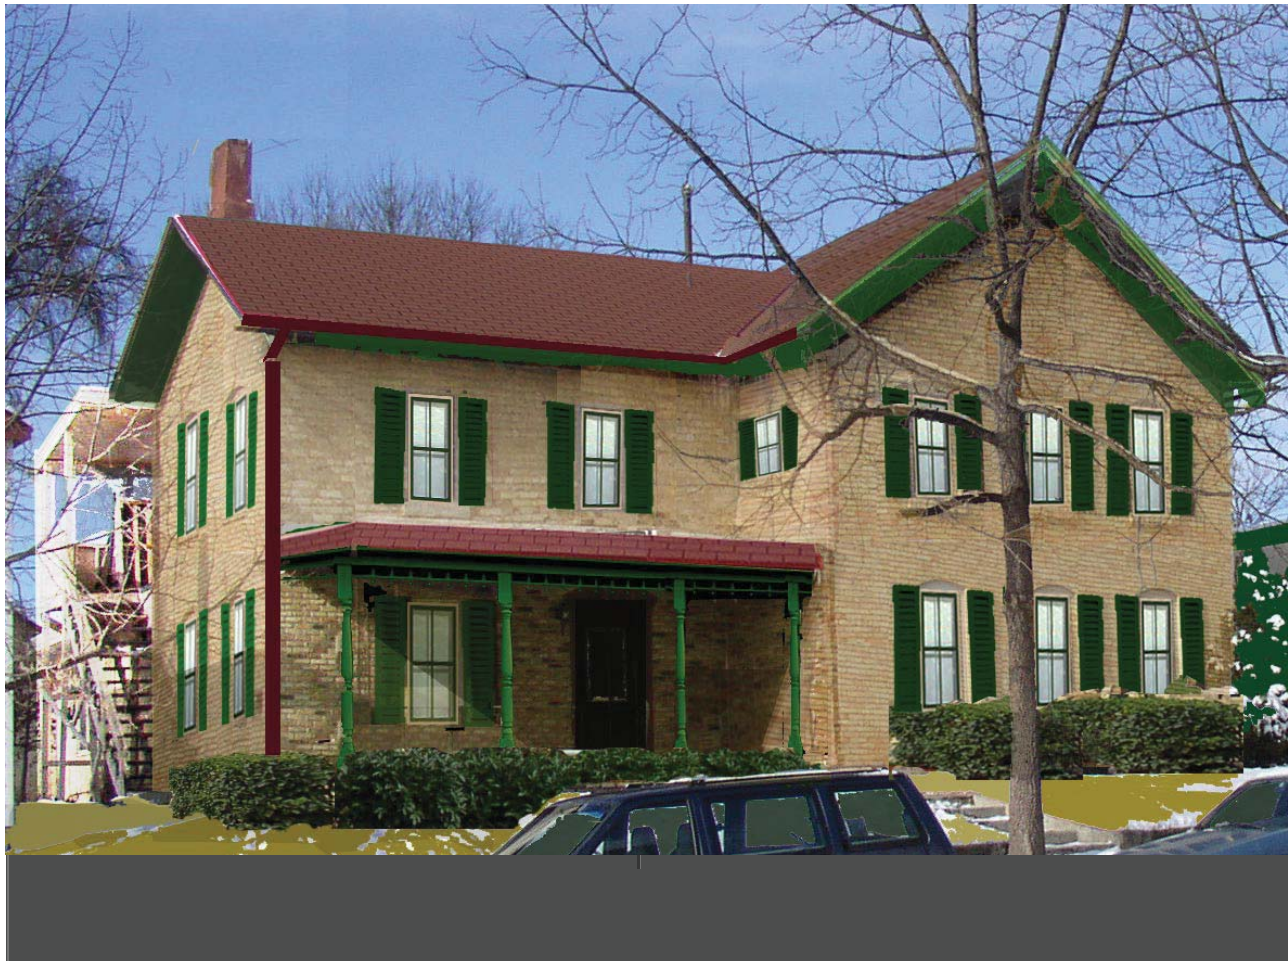
JOSEPH ESS HOUSE (1886)
217 North Walnut Street

- Historic porch structure exists intact at rear of house.
- Building has been covered with thin layer of stucco that could be stripped, with masonry underneath repaired.
- Existing window shutters are historically inaccurate. Replace them with shutters to match the width and radius-top window openings.

- Repaint all trim a lighter color, with paint accent scheme to emphasize the nice roof edge brackets. Retain the historic half-round drainage gutter wherever possible.
- Remove stucco. Repair and repoint masonry and mortar underneath.
- Reconstruct front porch to more accurately match historic details of 1880 period. Although photographic evidence has not been located, existing wrought ironwork appears to be lighter and more slender than would be expected on an historic building.
- Replace windows with insulating double-hung sash inserts to match historic configuration.
- Replace shutters to match the width and radius-top window openings.

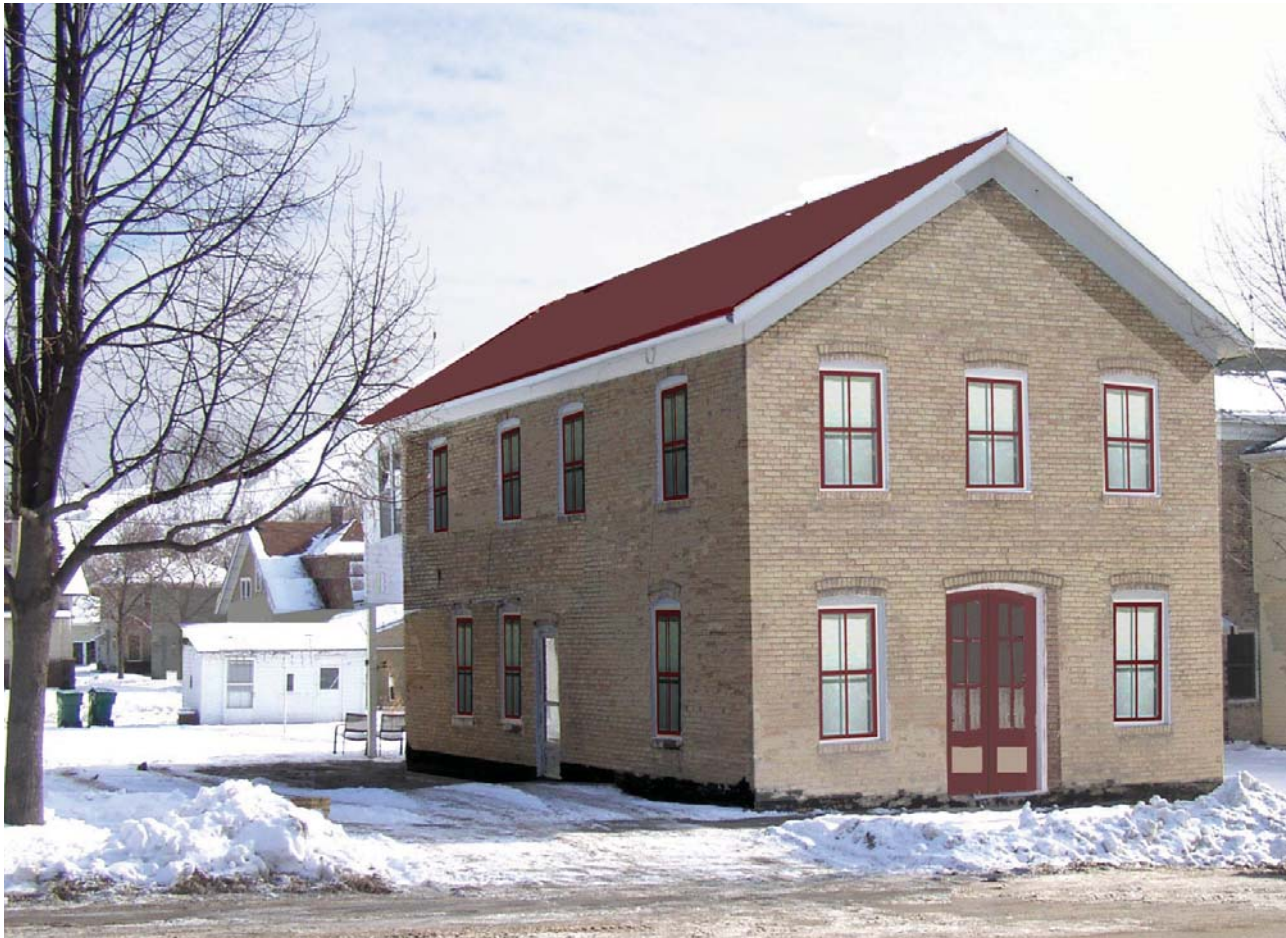
FRANK MIESELER HOUSE (1865) *206 North Walnut Street*

- Brickwork and masonry exist in generally sound condition. Selectively repoint and repair open mortar joints.
- Replacement window sash has been installed in historic frames. Visual effect is historically accurate.
- An interesting, early-period free-standing brick smokehouse outbuilding exists in back, covered with stucco.

- Repair and tuckpoint brick at chimney. Repair or replace chimney flashings for watertightness. Repoint and repair brick mortar joints where deteriorated from chimney leakage.

- Replace well-worn asphalt shingle roof.
- Doors and windows exist in relatively sound condition. Repoint sloping brick window sills for watertightness. Repaint brick window “returns” at jambs of masonry openings a neutral cream color.

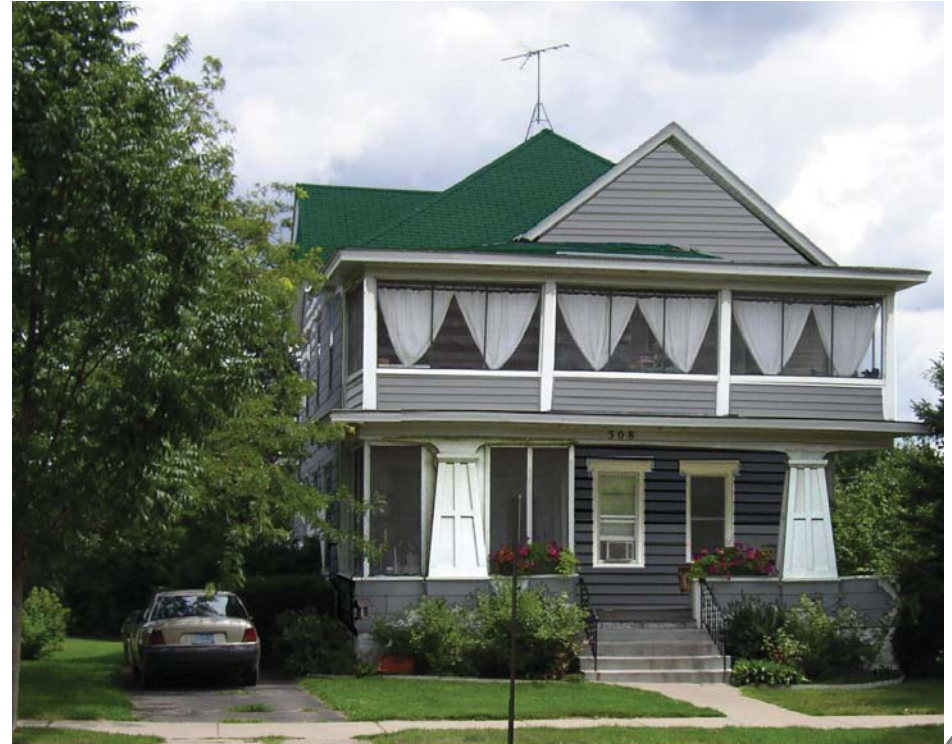
GRACE GIBSON HOUSE (undated)
308 North Walnut Street

- This building is currently the subject of careful rehabilitation planning on the part of the property owner consistent with the historic character as the house.
- Structural cantilever beams that support the upper porch show signs of distress and settlement. In the course of renovation efforts, a careful structural analysis of the porch structure should be made by a qualified engineer.
