## CHASKA FLOUR MILL (1897)

## Preservation Success Story

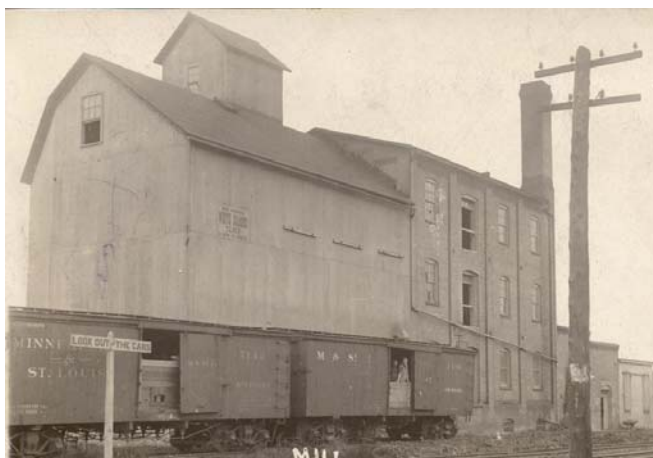
- This property is one of several previously rehabilitated buildings in the downtown district. Prior renovation work has been done that is remarkably sensitive to the architectural character of the historic context of a building that would have been regarded as “utilitarian” in its day. It is an excellent example in all respects.

- More reliable, prefinished, standing seam metal roofs have been used in lieu of the corrugated sheet metal that once existed on this building.
- Brick and mortar have been cleaned and repointed, and are in good, sound condition.

- Wrought metal, masonry rod tie caps have been placed and accentuated in a decorative way.
- In the previous renovation of this building, design judgment was to re-build the full-width, side “loading dock” (balcony/deck) in an industrial vocabulary consistent with historic use of the building.

- Cap flashing is loose and unsecured at facing brick that appears to have been added in the lower 8-feet of the west wall. Repair brick and mortar at one, open vertical masonry joint in this area (northwest corner).

- Door openings in the three-story mill part of the building appear to have been permanently secured and made inoperable. An exterior, metal pipe guard rail might also be added at these two fixed openings.

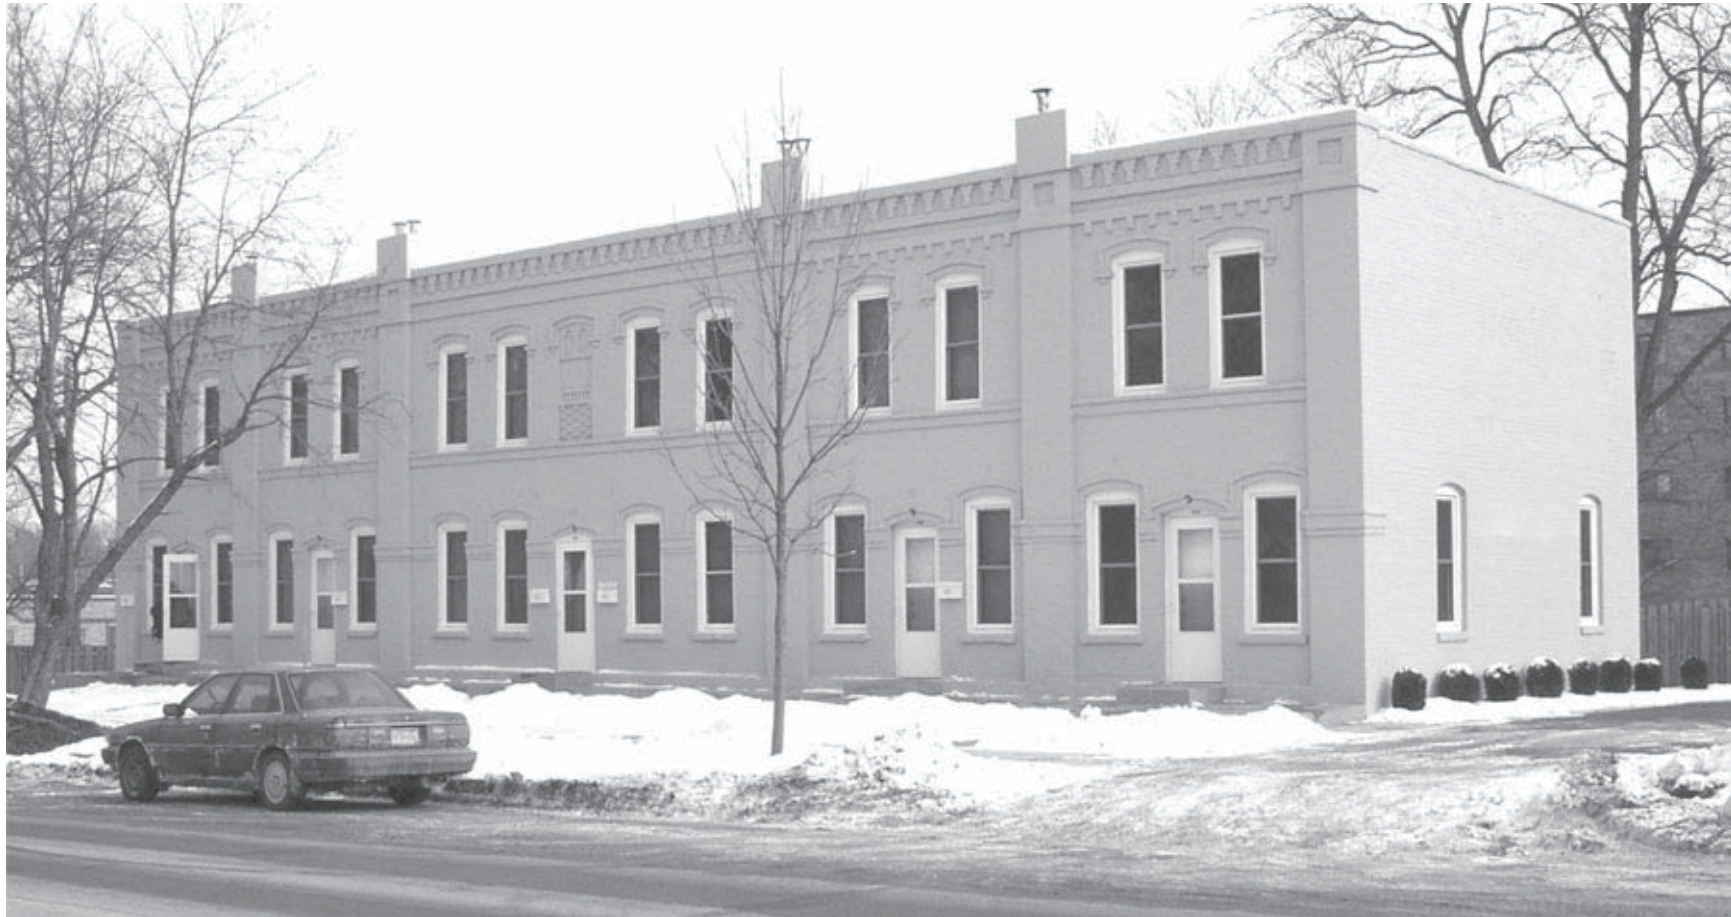
In the course of recent renovation, the exterior of this otherwise sound brick building has been unfortunately coated with sand-textured, pigmented masonry sealer (*Thoroseal*<sup>™</sup>-type product). Though the applied coating produces a cosmetically “uniform” appearance, this type of exterior coating treatment is not removeable and should not be applied on other buildings.

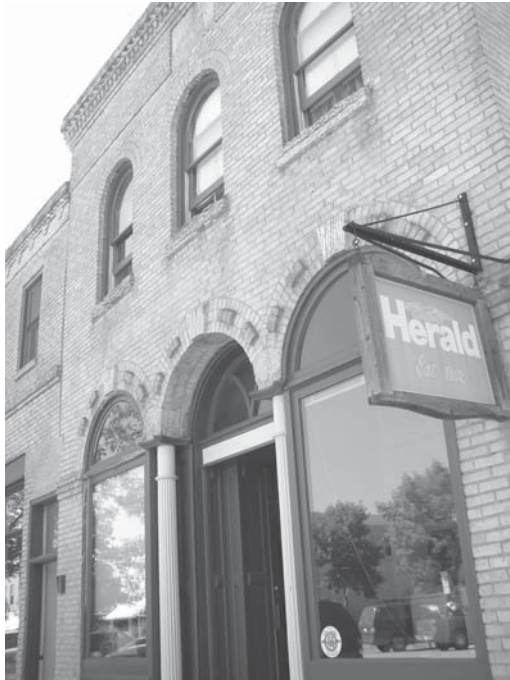
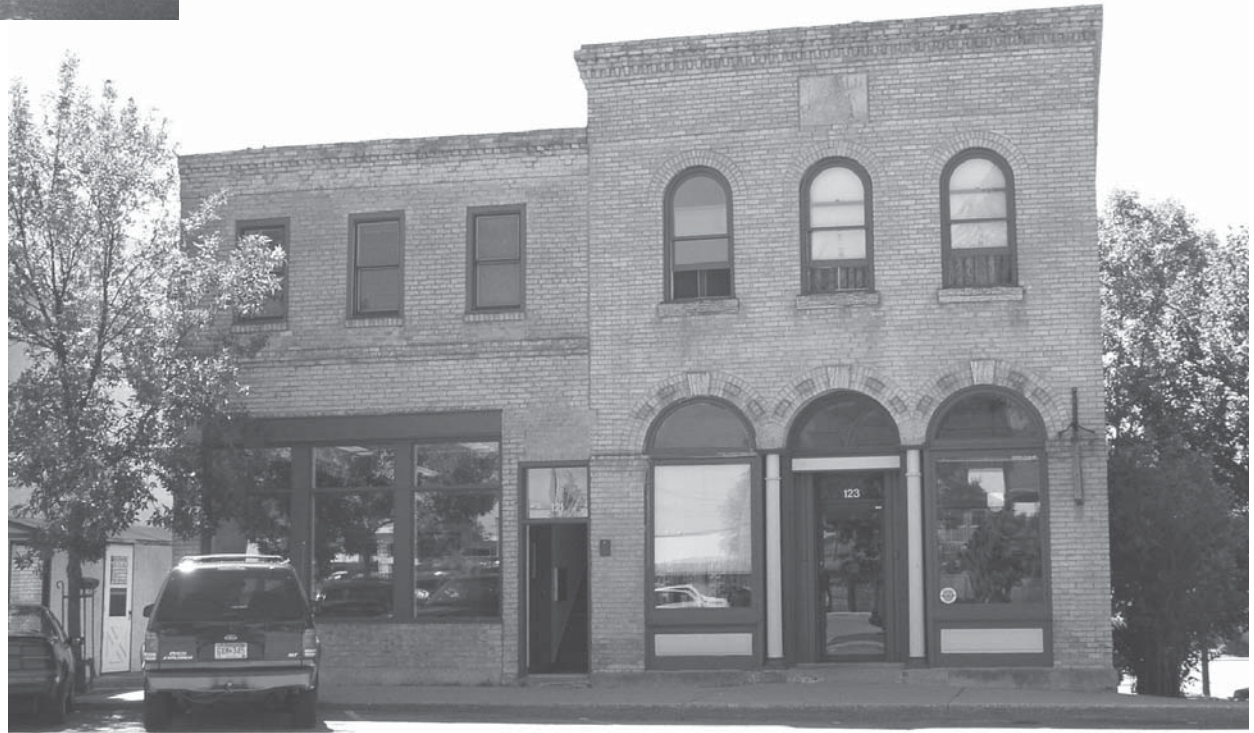
**CHASKA HERALD BUILDING (1871)**  
*123 West Second Street*

- Building is in generally excellent, sound repair, and well-maintained.
- Inspect roofing and flashings. No cap flashing is visible atop the front façade.

- Repair parging just below front-façade bulkheads where foundation is becoming exposed.
- Touch-up paint on cast iron columns with rust-inhibitor.
- Condition of all wood-framed elements added to the back of the building is generally quite good. These porch and egress stair additions provide an excellent example for other property owners of how modern elements can be added to an historic Chaska commercial building without detracting from its historic qualities.

- Questionable foundation drainage along west wall sidewalk could be improved with installation of sloped paver materials in place of the plant materials that currently grow on this side.

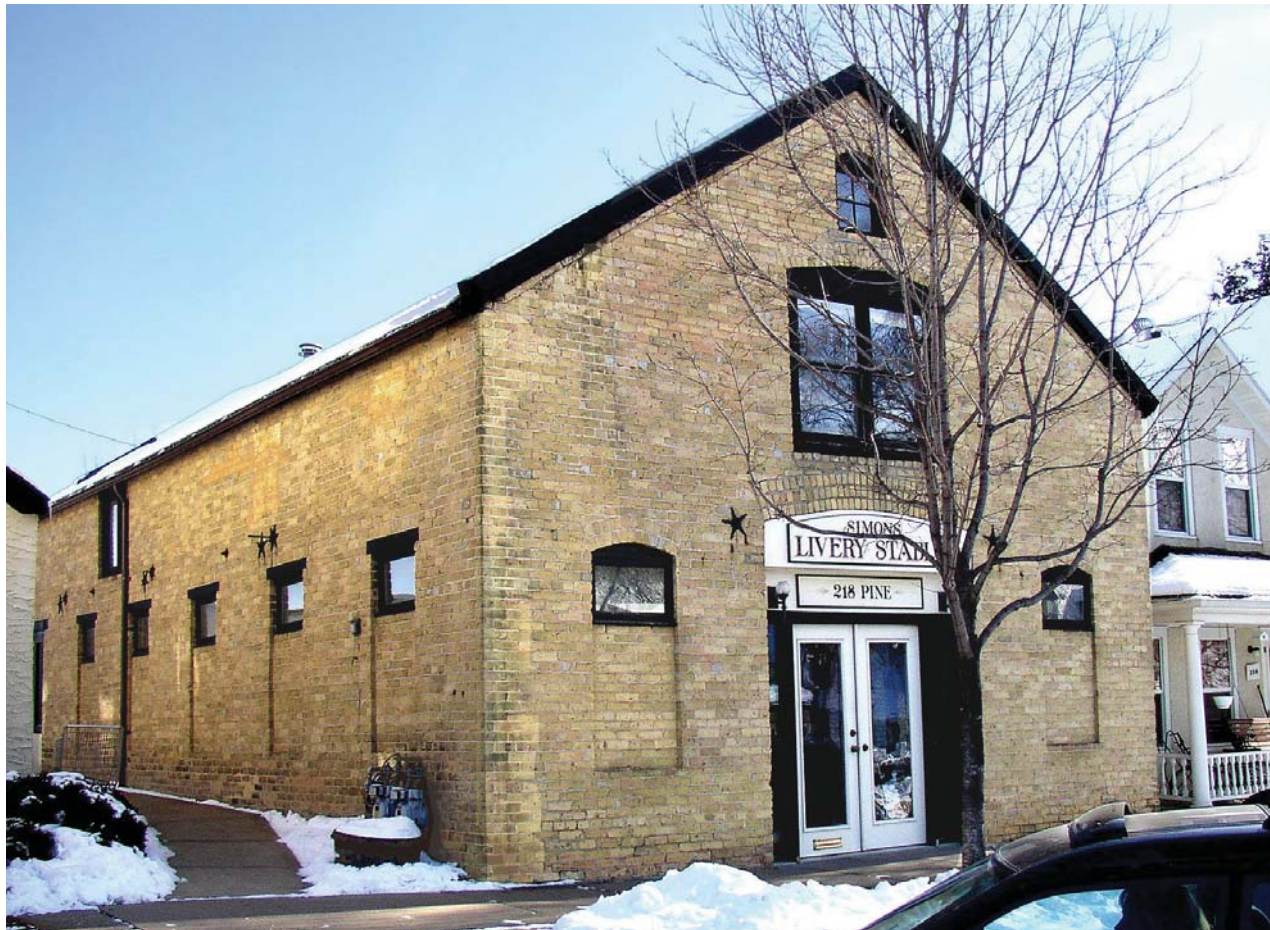
## SIMONS LIVERY STABLE (c. 1886)

- This property is one of several previously rehabilitated buildings in the downtown district. Renovation work has been done that is remarkably sensitive to the architectural character of the historic context of a building that would have been regarded as “utilitarian” in its day. It is an excellent example in all respects. Even the small high windows on the north elevation are reflective of the pattern of livestock stalls associated with the building’s historic usage.

- Building signage and entrance are sensitive and appropriate. Brick arch over the entrance appears to have been rebuilt.
- Eaves, fascias, and trim are all in excellent condition. Soffit screen material is coming loose in southeast corner of south side elevation (near the front).

- Light repair of brickwork may be in order in the southeast corner and to the lower left of building entrance.
- Brick and mortar are in excellent repair. Brick is distinctive in that it shows numerous impurities contained in the clay body, comparable to the Brinkhaus Livery Stable (a.k.a. Minneapolis House Livery, near City Hall on West Fourth Street) and the Minneapolis & St. Louis train depot on Highway 212.

- Touch up paint on window trim of two small arched windows on front façade.
- Good, positive drainage toward street from the side yard on the north assure that moisture will be drained away before it can cause damage to historic materials.

- Remove weed trees that have begun to volunteer at back of building, to prevent damage to eaves and air conditioner condensers.
- Consider an alternate facing material on the bulkhead below secondary entrance sidelight. Current painted material shows signs of weathering.

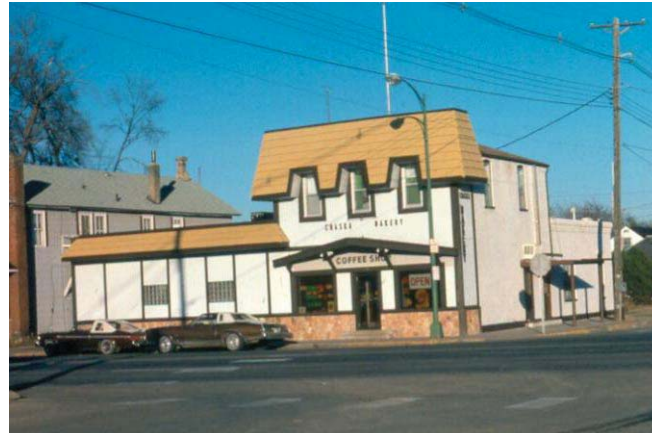
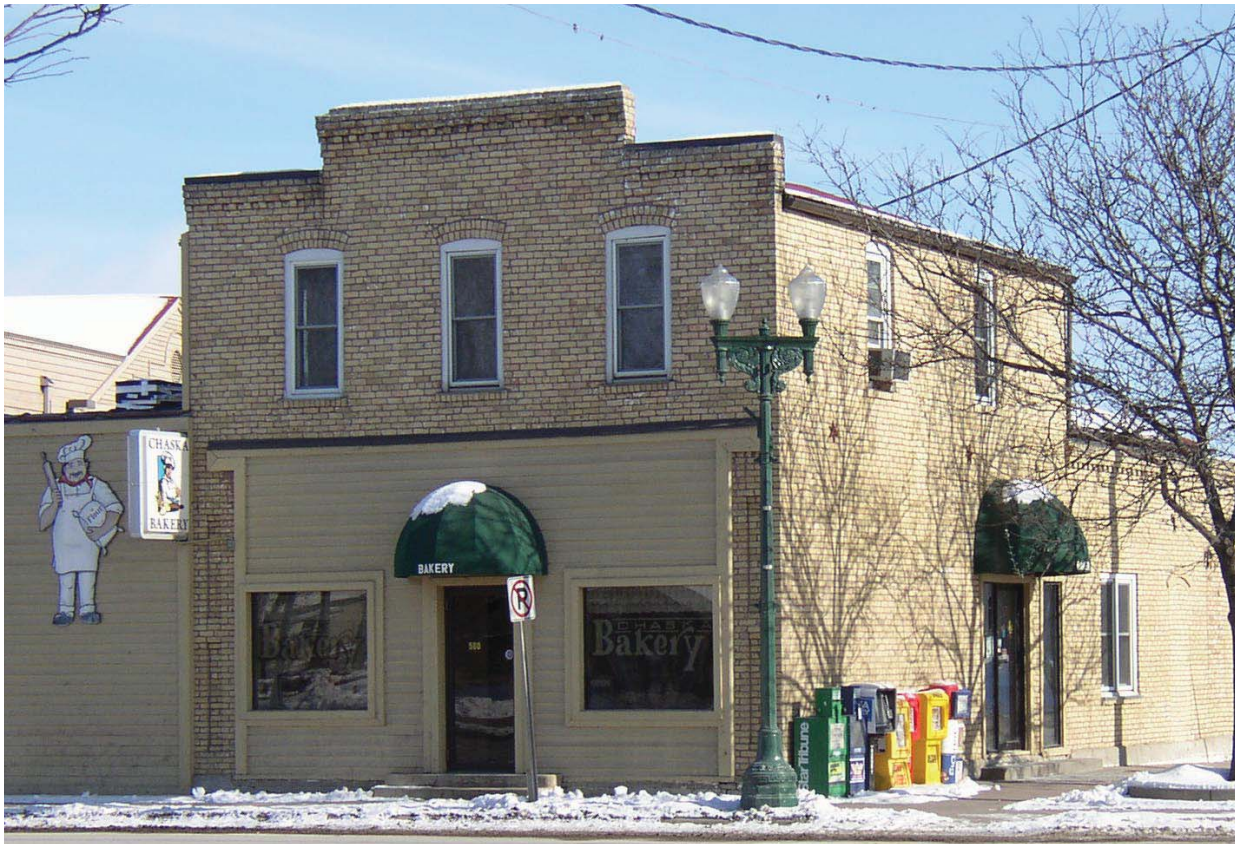
## CHASKA BAKERY 500 North Chestnut Street

- This building is one of several previously rehabilitated buildings in the downtown district that has been renovated in a manner sensitive to the architectural character of the historic context.

- Repair sealant (caulking) between wood storefront trim and brick façade.
- Window air conditioners have been relocated to secondary façade of building. Enclosure of a through-wall unit air conditioner behind canvas awning at side entry provides a good example for other property-owners.

- Paint trim of upper story windows at rear of building.
- Replace or reinstall missing cap flashing at top of wall in back of building (along Fifth Street elevation).

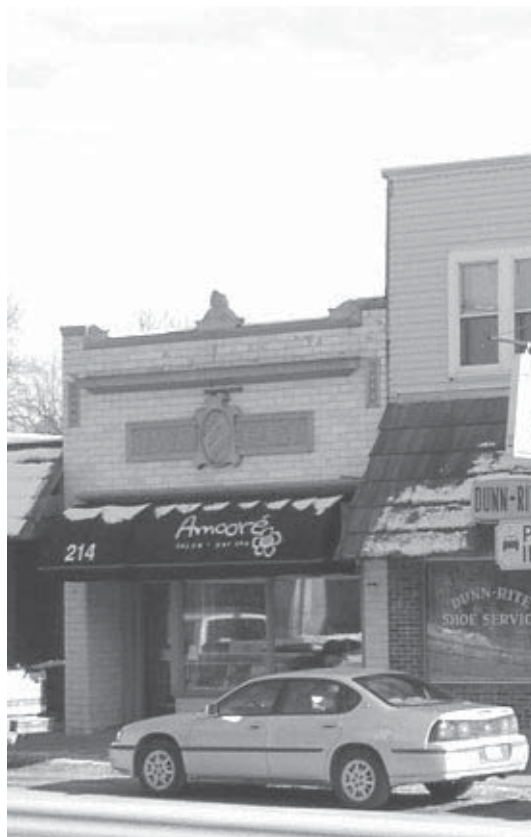
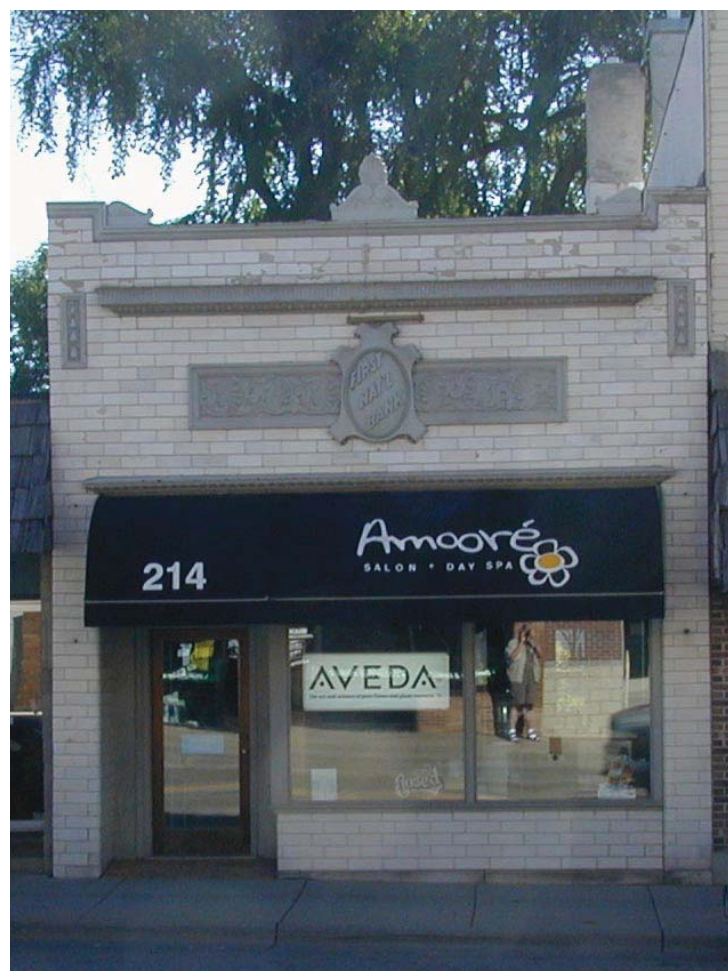
214 North Chestnut Street

- This wonderful building has been sensitively and appropriately preserved in a manner consistent with historic character of the property.
- Preservation maintenance of the historic pressed metalwork is especially impressive.

- Touch up glazed masonry units (clay tile) in a few locations where glazed surface has spalled slightly.
- Lightly scrape or spot strip pressed metal ornament and repaint with rust inhibitor, continuing the present restrained color scheme.

- Touch up the heavy body stain on wood storefront trim.
- The existing canvas awning is nicely handled, integrating signage and street address and emphasizing the entrance. Transom windows have been nicely maintained.

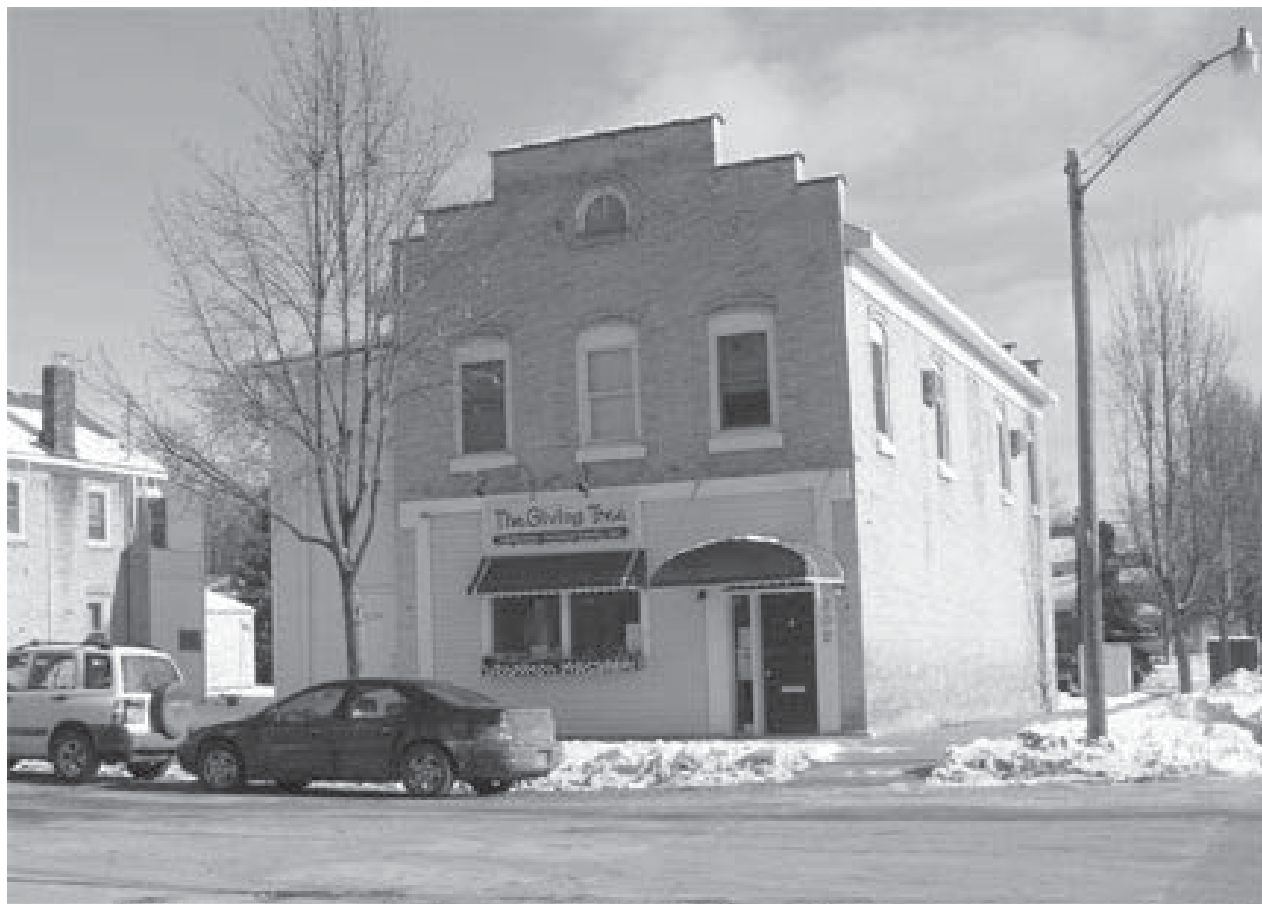
## FABER BUILDING (1872)

- Some corbelled masonry projections above the parapet line have been removed. A historic photo of this building's original appearance, showing upper story awnings, first floor arched openings, and corbelled brick parapet details is available in the collections of the Chaska Historical Society.

- Upper portion of front façade is intact and in good condition.
- Existing vinyl replacement windows do not completely fill the masonry openings as they would have historically. Replace with sash inserts to replicate the historic profile.

- Some window openings have been partially in-filled with substitute materials to reduce opening size.
- Parging material at top of foundation is installed in a way that does a good, effective job of shedding water away from exterior wall along the south-facing sidewalk. Repair parging in one small area of foundation.

- Limestone sills are extensively weathered and most have been covered with metal panning. This appears to be a satisfactory solution that meets the Secretary of the Interior's Standards for "reverseability". In two locations where limestone remains exposed, there is no critical need for repairs.

- Repair and tuckpoint brick at step-gabled parapets.
- Repair brickwork over one window opening where brick arch has been displaced.
- Replace existing windows with sash inserts to replicate the historic profile.
- Rebuild the decorative parapet cap according to historic photos that show extensive corbelling of the brickwork.

- Consider a strategy of relocating unit air conditioners to the upper part of window openings, and then concealing them on the exterior by using canvas awnings, similar to the way this has been done on the Chaska Bakery.

- Replace vinyl cladding/siding materials on framed structure along north side of building with historically appropriate materials to match the historically accurate details of the side porch.

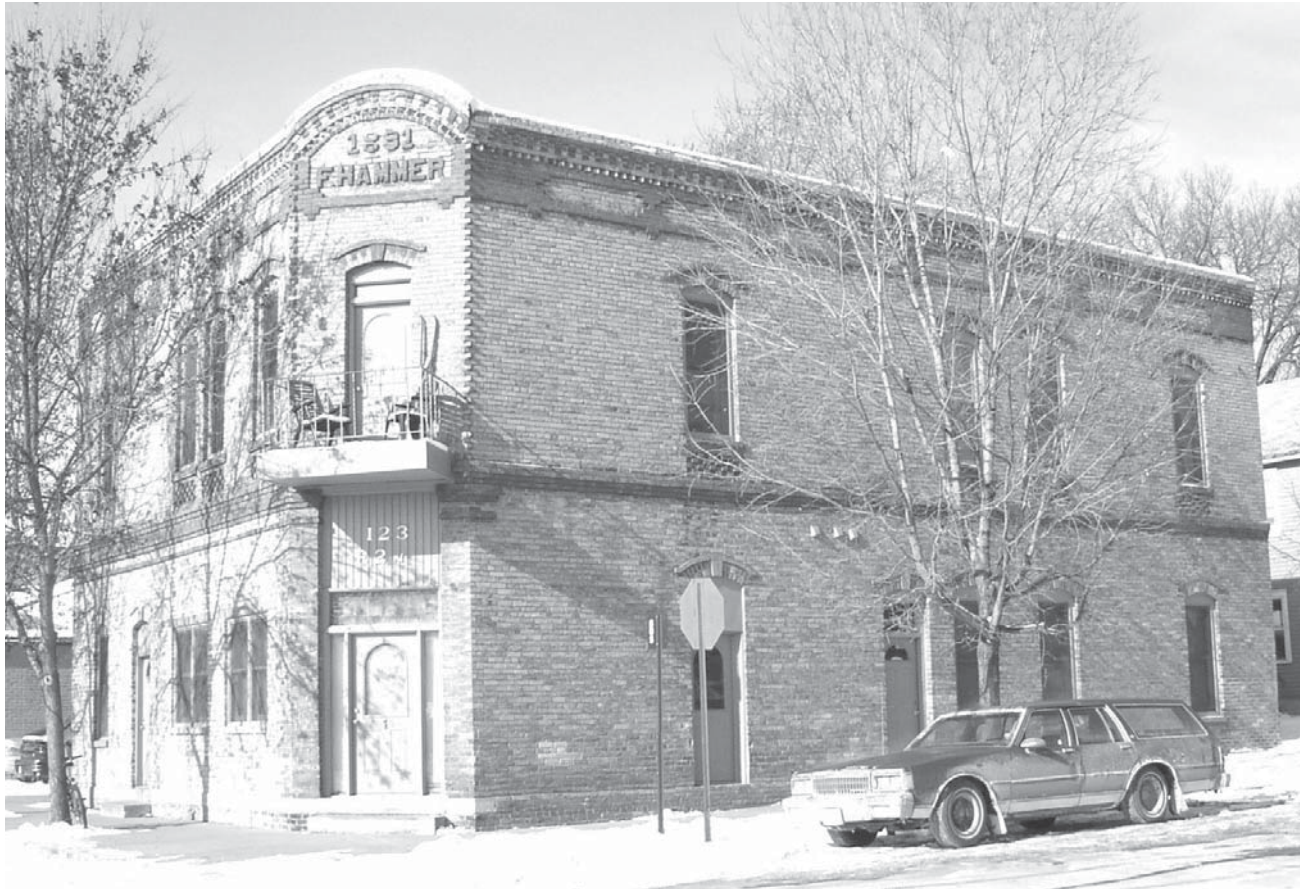
NATIONAL HOTEL BUILDING (1891)  
(former F. Hammer Building)  
*123 East Second Street*

- South-facing wall has been substantially modified over time on the first floor. Photographic evidence is inadequate to justify rebuilding it, so the changes should be accepted consistent with the Secretary of the Interior's Standards that allows for changes over time to become part of the historic fabric of a building.
- Kasota limestone sills and thresholds exist in very good condition on this building.
- This building has recently undergone window replacement and offers an excellent example for other property owners of how new, replacement windows can accurately match the historic character and dimension of historic window openings.

- Inspect roof and flashings. Repair parapet or replace cornice cap materials.
- Scrape and clean the contrasting, accent red brick trim that currently shows flaking paint.

- Railing at upper balcony is much too “slender” for the historical period of this building. Reconstruct projecting balcony and railing to be more consistent with historical examples of bracketed balconies that exist on many other commercial buildings in the downtown district.

- Install new, more subtle building address sign, possibly consistent with other buildings in the historic district.
- As a third-level priority, consider replacing brick window sills on south wall with cast stone or limestone to match historic stone sills that exist on this building.

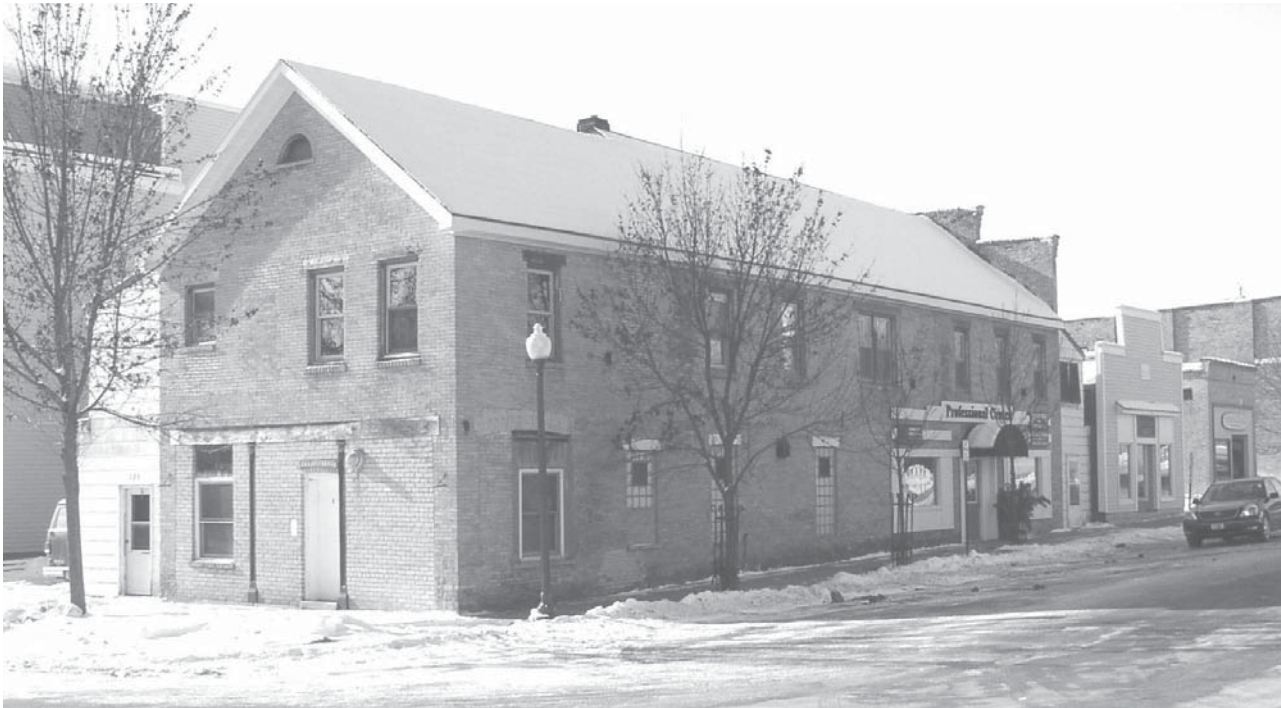
- Exterior of this building has previously been damaged by abrasive sandblasting.
- Eave and soffit venting are in satisfactory condition for attic ventilation.
- Bottom four courses of brickwork show evidence of deleterious "rising damp" from capillary absorption of ground water. Consider adding a watertable "wash" (similar to the nearby Faber Building) to cover the bottom four brick courses and seal the joint between building wall and sidewalk.

- One window opening on the upper floor facing east has been bricked in. Restore this opening by either reinstalling the window in its original location or by recessing brick to form a shallow window recess with lintel and sill to restore the symmetry that was original to this facade.

- Historic building entrance on the east has been filled in with brick. Cast iron columns and lintel beam remain visible. Reopen this façade by installing storefront materials that are consistent with historic character of building as it appears in photos. Prime and paint all ornamental ironwork with rust inhibitor.

- Stone sill at the bottom of the north wall appears to be in sound condition.
- All brick window sills are seriously weathered and in need of repair so that they shed water.

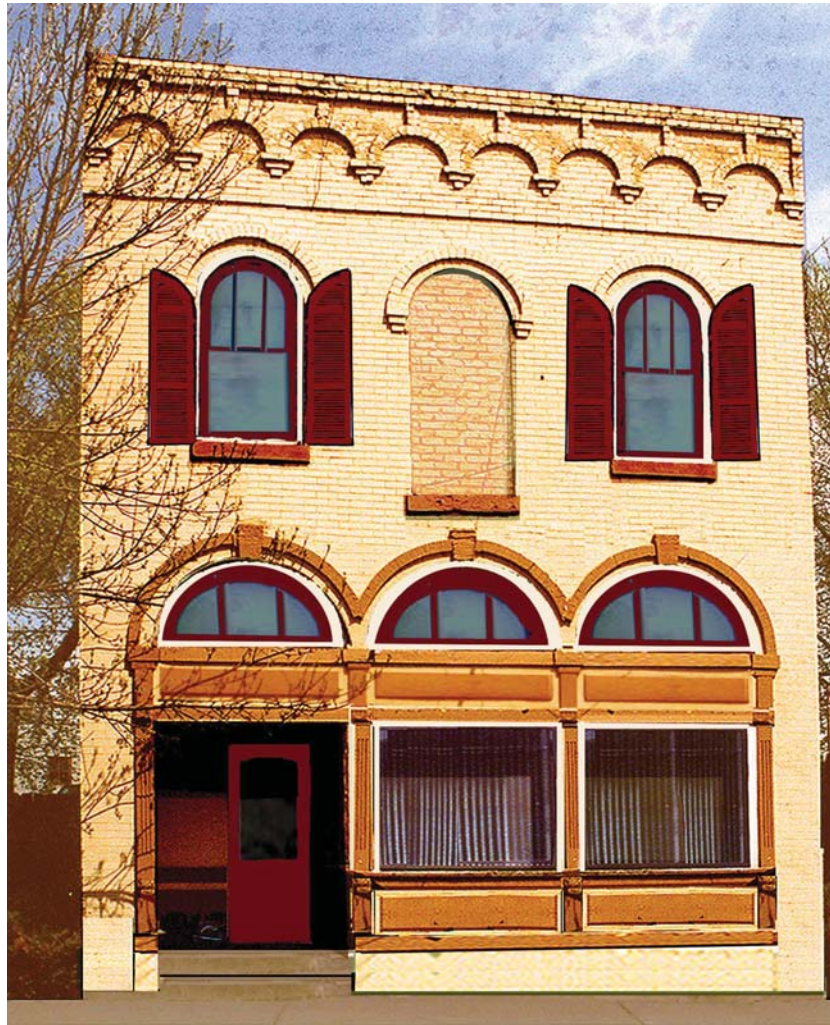
**HAMMER & BEIERSTETTEL BLDG. (1877)**  
*107 East Second Street*

- Patch, repair, reattach and repaint galvanized metal cornice.
- Chemically stripping paint from front wall would be a medium priority, to restore the building to original appearance.

- Patch holes in brick on north wall.
- Remove coverings that obscure the cast iron columns which appear on historic photos. The original ornamental columns are believed to remain in place. Wood trim that has been added in the course of recessing the entrance is compatible with historic features of the building.

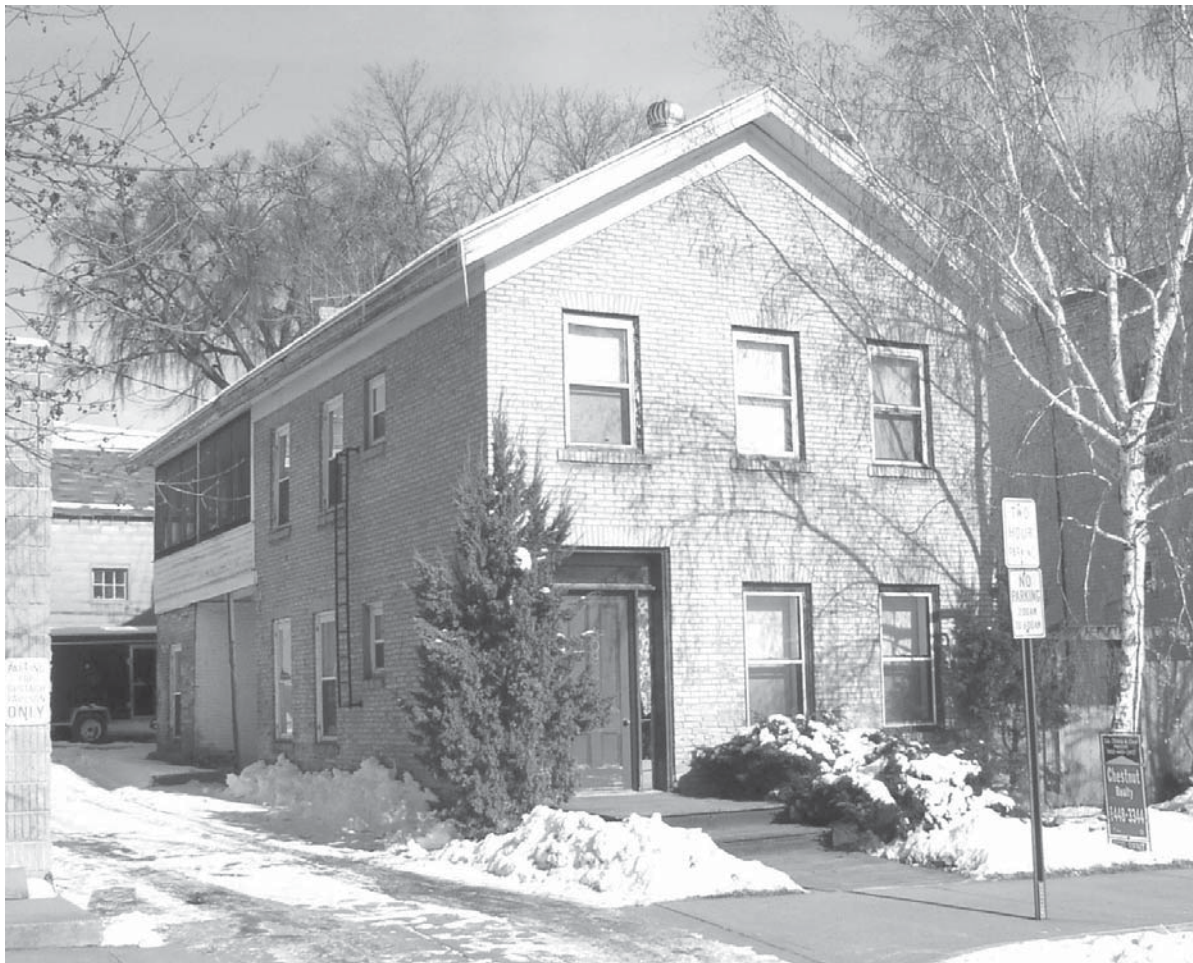
109 East Second Street

- Major repair of fascia and soffit is called for on the west side.
- Spot repointing of brick joints is called for below first floor window in southeast corner, where water damage has occurred.
- Storm windows and sash are in generally good and repairable condition.
- Brick chimney shows signs of pulling away from wall, and top of chimney needs to be rebuilt.

- Inspect fascia and soffits. Repair and repaint as needed.
- Spot re-point (tuckpoint) mortar joints as needed with lime-rich mortar. Spot repointing of brick joints is called for below first floor window in southeast corner.
- Restore operable window shutters based on physical evidence of shutter bracket hardware on window jambs.
- Replacement windows should be regarded as a medium priority.
- Repair and brace support posts under rear/side porch.
- Work with neighboring property owners to maintain or screen trash and storage area at rear of Chestnut Street properties.

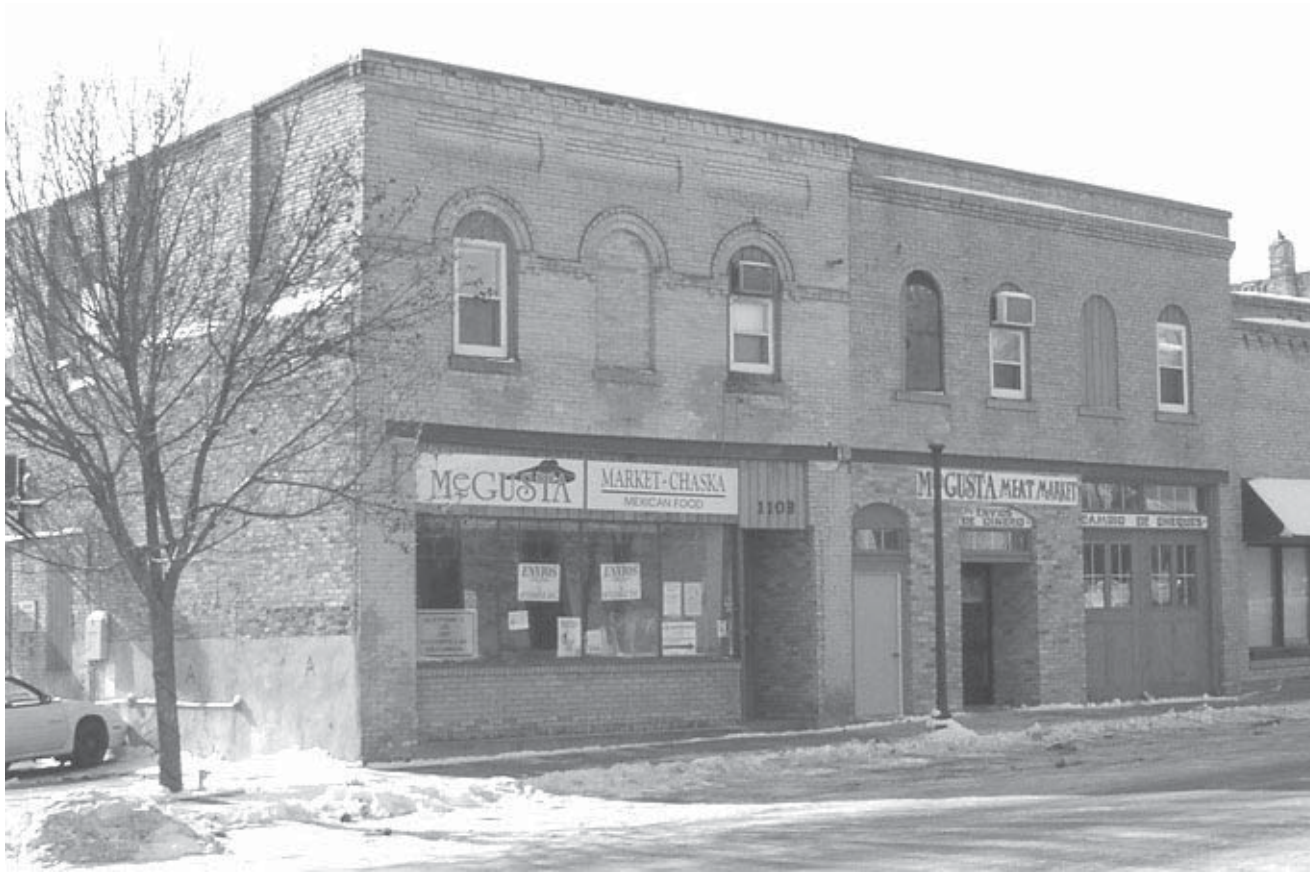
## Existing Condition

- Exterior of this building has previously been damaged by abrasive sandblasting. Otherwise, the brick and mortar appear to be in generally good condition, needing only spot repointing.

- Inspect roofing and repair or replace parapet capping (counterflashing) materials for weathertightness.
- Relocate unit air conditioners away from main façade, where they appear to be causing significant moisture problems on the historic brickwork.

- Upper windows have been replaced with windows and infill panel materials that do not match historic character.
- Replace small windows with full-sized, insulated double-hung window sash in historic “radius top” configuration, similar to the Hammer & Beierstettel building across the street.

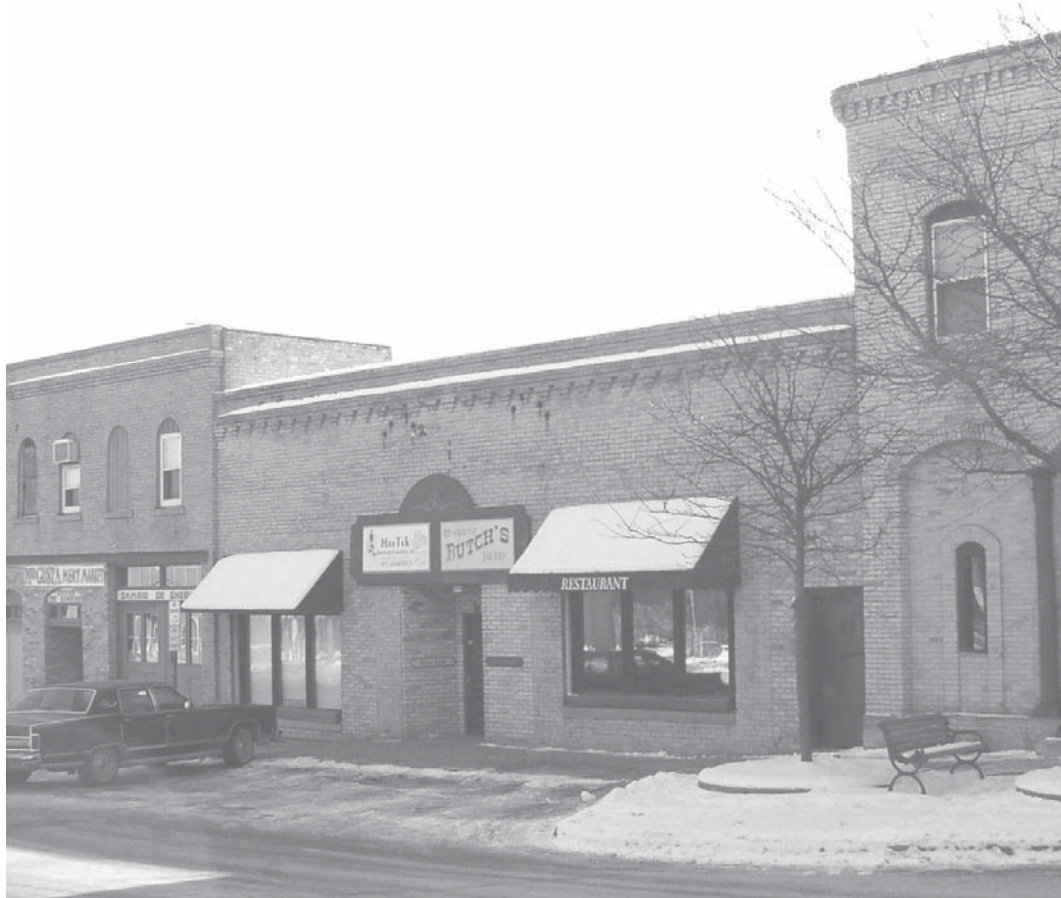
## Existing Condition

- Exterior of this building has previously been damaged by abrasive sandblasting and more recently by a fire that occurred in the adjacent Butch's Bar building to the west.
- Streetfront façade has been substantially reconstructed, but is consistent with the scale and historic fabric of this commercial block, particularly in terms of the corbelled brick cornice work.

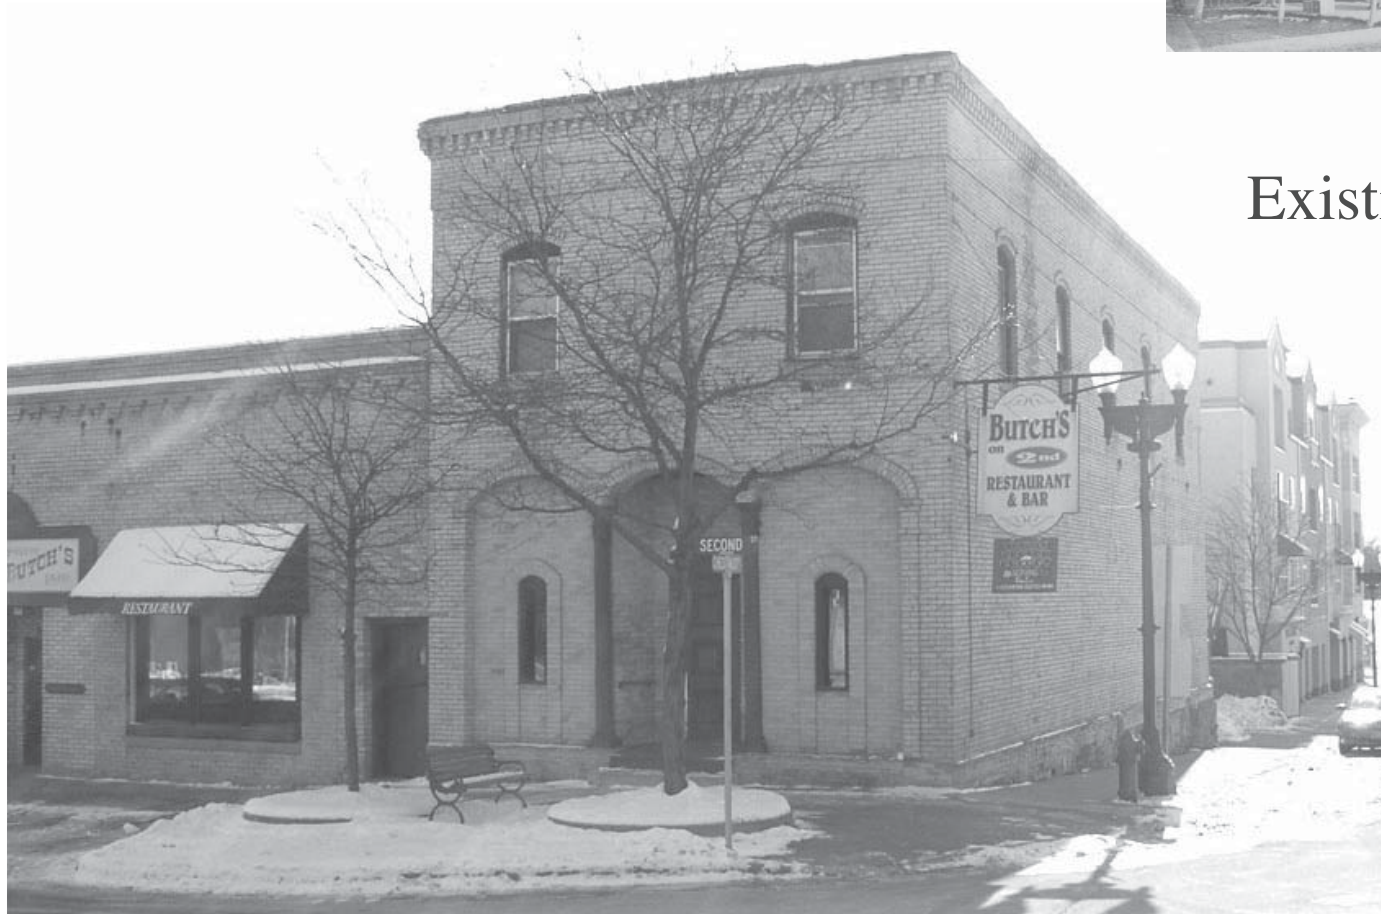
- Exterior of this building was previously renovated and at some time its exterior fabric was damaged by abrasive sandblasting. More recently a major interior fire has displaced the business that operated in this location for many years.
- Because of its association with Chaska's business community for several generations and its prominent corner location, this building is a pivotal property in Chaska's historic downtown district.
- In the aftermath of a disastrous October 2003 fire, a significant opportunity exists for community development resources to contribute toward restoring this pivotal building with such great potential for anchoring the historic downtown.

- Install period-appropriate replacement windows in all openings that have been affected by the fire. Historical photos show “6 over 6” windows on the upper story of this building.

- Reconstruct street-level storefront for more “lightness” and greater transparency.
- Repair parapet cap and selectively repoint brickwork around upper story windows.

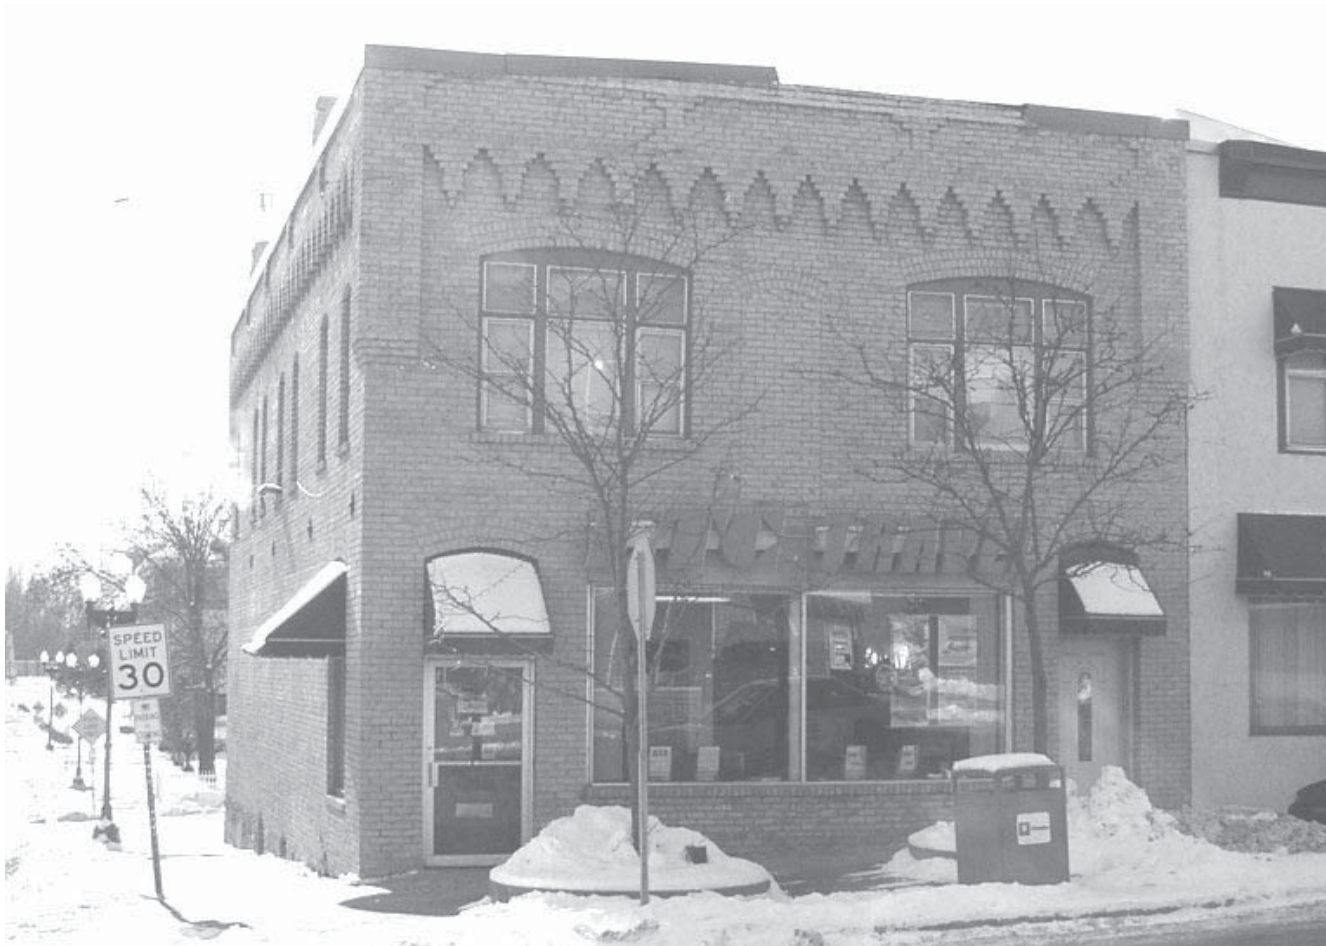
*101 West Second Street*

- Elaborate brick corbelling at the cornice line (front and side walls) is an especially distinctive ornamental feature of this building.
- Exterior of this building has previously been damaged by abrasive sandblasting.
- Existing upper story windows suit the historic character of the building almost perfectly. Stained glass in the upper story transom windows is an especially beautiful feature to be preserved.

- Repair cornice cap and cap flashing. This is a serious hazard as it exists, requiring immediate attention. Building tenants were advised that there appear to be loose bricks behind the parapet flashing about to fall onto the sidewalk.

- Previous mortar repointing appears to have been done in a somewhat careless manner, resulting in mortar remaining on the face of bricks. Spot tuckpoint and repair brickwork with lighter-colored, appearance-matched lime mortar.
